APPENDIX C: GAMPE FIELD TRIP GUIDE

Geotechnical Asset Management Peer Exchange (GAMPE)

FIELD TRIP GUIDEBOOK

August 28, 2019

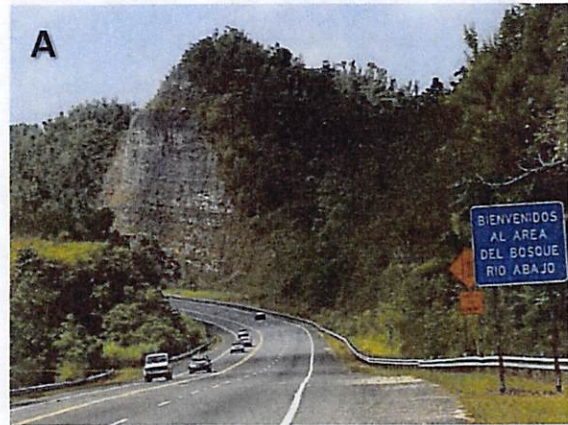
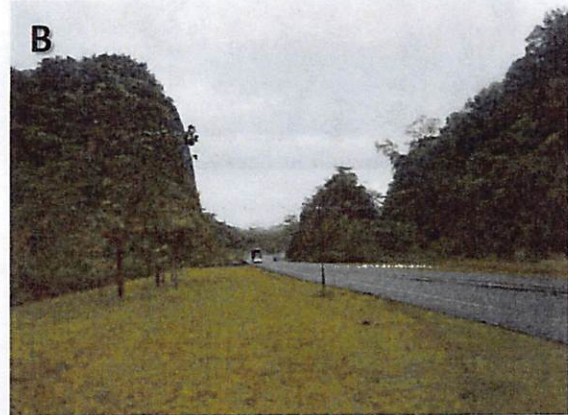
This rock slope represents the section highway PR-10 that crosses the Río Abajo Forest. The nearly vertical rock cuts and small rockfall catchment areas between the roadway and the base of the slope resulted in part from the agreements established between DNER and PRHTA. To reduce impacts to the forest, the total width of this section of PR-10 had to be kept as small as possible.

The resulting rock cuts have not produced any significant rockfalls since their construction about 25 years ago. However, the rock of these “mogotes” (Montebello Limestone member of the Cibao Formation, Tcm) is not homogeneous, and the effects of differential erosion and raveling are starting to become an obvious problem. (See figure 12.)

Photograph **A** shows the view of the slope towards the south and photograph **B** towards the north. During our stop the vehicles will park on the relatively wide unpaved and grassy shoulder seen on photograph B. This wide area is a sinkhole that was “filled” during construction. (See 1987 and 1998 aerial images.)

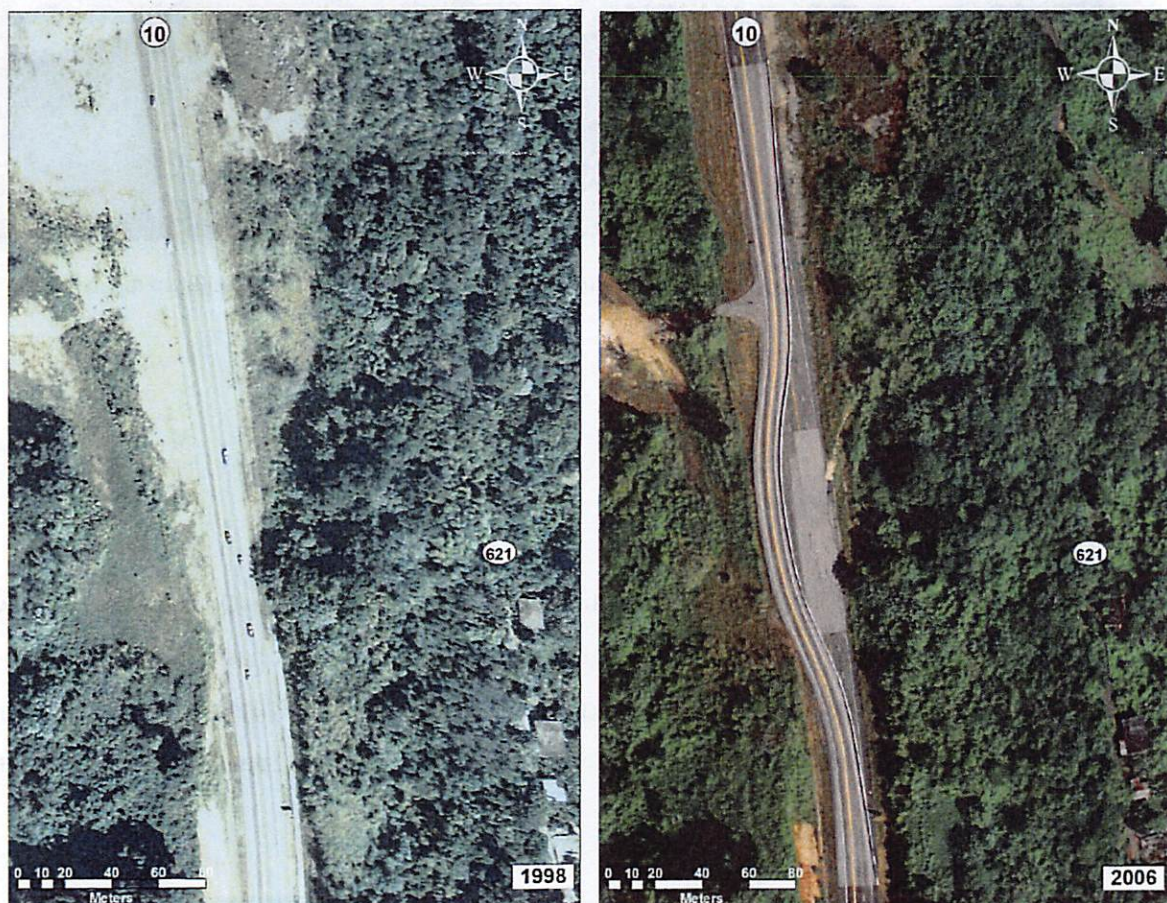
Figure 14. Condition of highway segment in 1998 and 2006, PR-10 Arecibo. (Stop #2)

This slope represents a fill or embankment section built over the contact between the Lares Limestone (Tl) and an underlying volcanoclastic sequence (Tj).

Figures 10 and 14 show that the fill started failing only a few years after construction ended. The conditions found during the landslide investigations determined that the best option available was to move this segment towards the west. Photograph A and B are from 2005 and 2008, respectively.

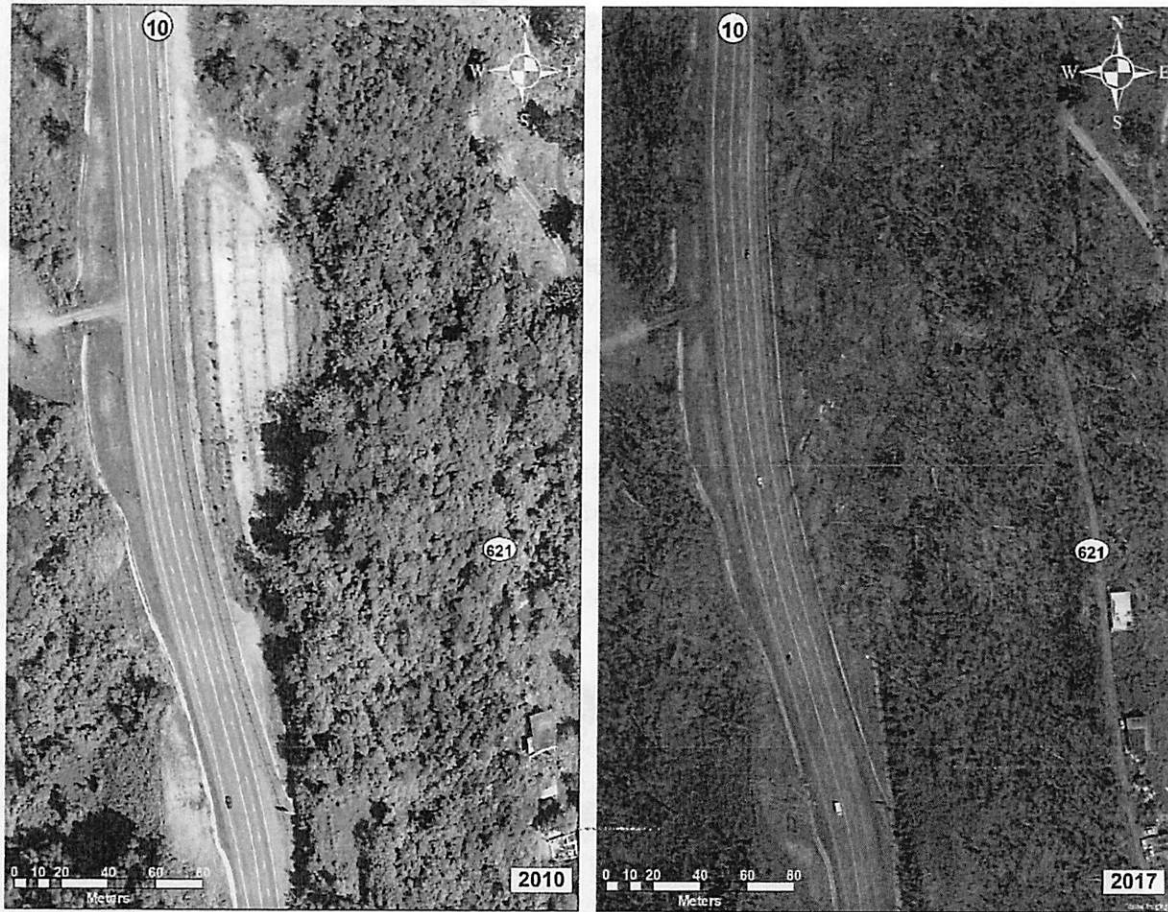
Figure 15. Condition of highway segment in 2010 and 2017, PR-10 Arcicibo. (Stop #2)

Figure 15 shows that by 2017 there was very little visual indication of the history of the site, and that inventorying, and description of site like this one can be improved by using aerial or satellite images.

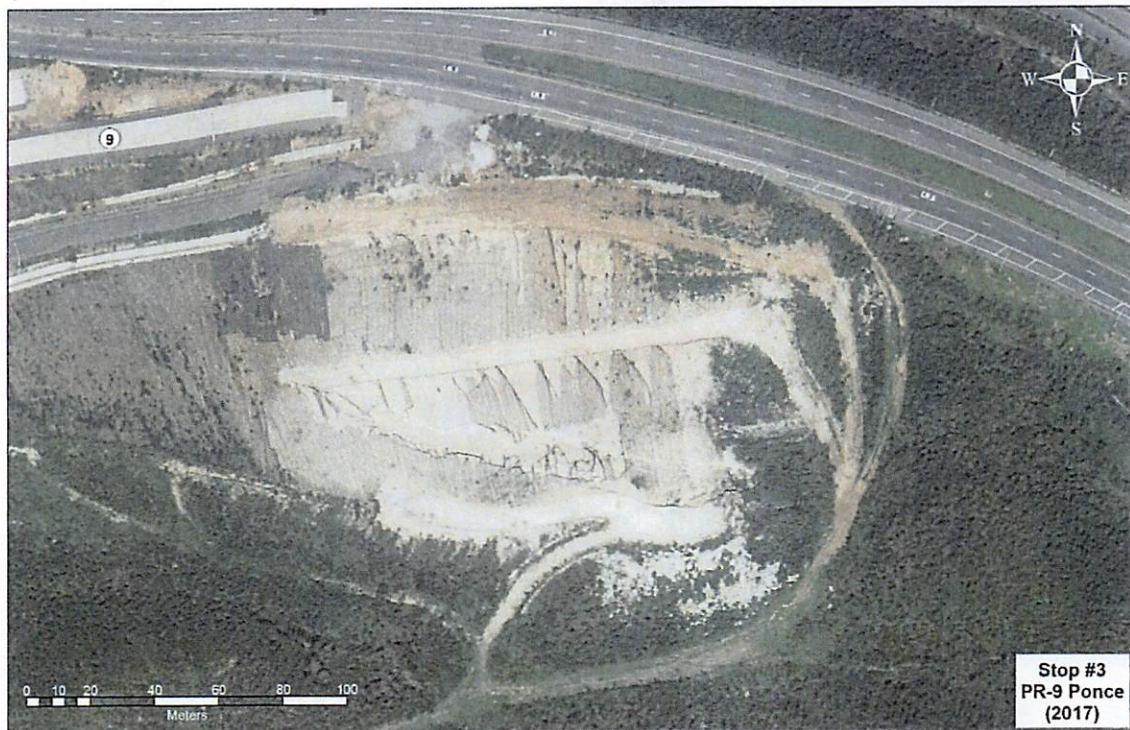
Figure 16. Slope failure PR-9 Ponce. (Stop #3)

This section of highway PR-9 involved the construction of two kilometers of new roadway and three bridges. Several slope failures have delayed its completion.

The geology of this landslide consists of Juana Díaz Formation Chalk Member and underlying Mudstone Member. The Mudstone member contains highly plastic and expansive clays (montmorillonite).

Geotechnical recommendations include flattening the slope to 6H:1V and adding a drainage key.

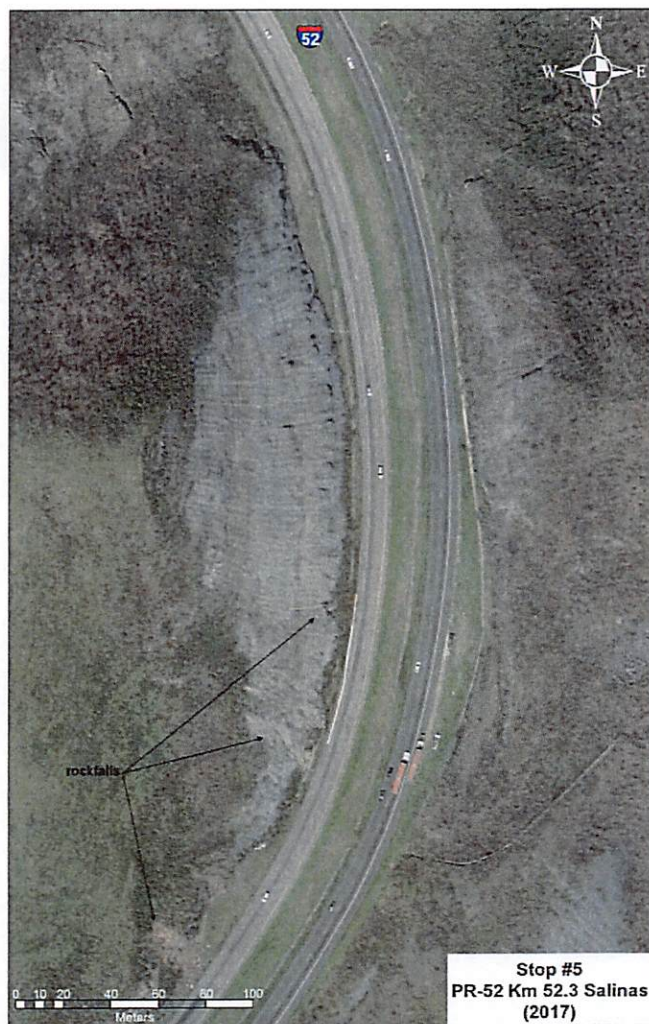
Figure 22. Rock slope and rockfalls at PR-52 Km 52.3, Salinas.
(Stop #5)

This rock slope (Fig. 22) has a total height of approximately 130 meters, including the rock cut and the natural slope above. And variable slope of 60° to 80°. The geology of the slope is composed of andesitic volcanic breccias (Kcvb) and flows (Kcf) of Formation C. (See figure 21)

This site poses many challenges including old steel mesh curtains of undetermined age that may require reinforcement or replacement. Multiple loose rocks can be seen stuck behind the steel mesh curtain and the natural slope above the cut is littered with loose rocks. There is virtually no rockfall catchment area.
