Field Testing of an Ultra-High Performance Concrete Overlay

PUBLICATION NO. FHWA-HRT-17-096

AUGUST 2017

U.S. Department of Transportation
Federal Highway Administration

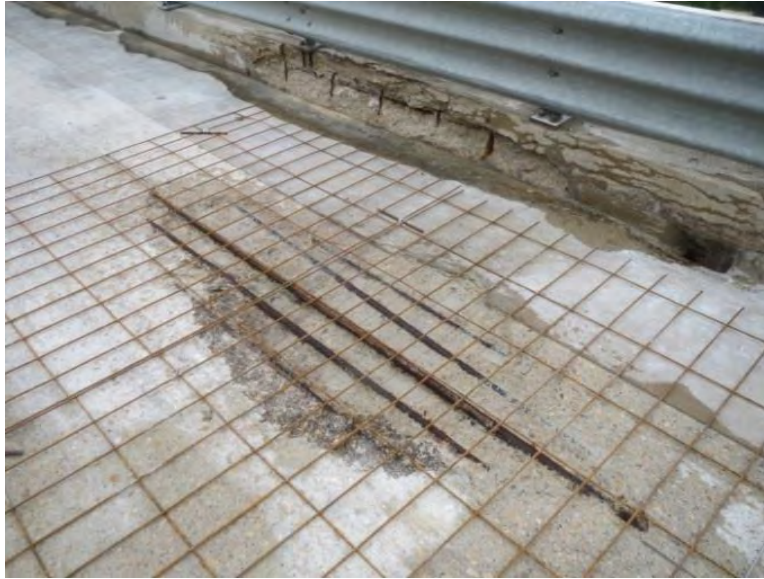
The bridge deck was beginning to exhibit delaminations and spalling along the northern (low elevation) curbside and at each end at the expansion joints. It is likely that the deterioration was related to chloride laden water ingress into the concrete and past the strip seal expansion joints, leading to reinforcement corrosion and freeze-thaw cycle-related distress. This deterioration had progressed to the point where maintenance actions were necessary. A UHPC overlay solution

Figure 16. Photo. Distressed region observed on the westbound lane over the pier 1 prior to installing the UHPC overlay.

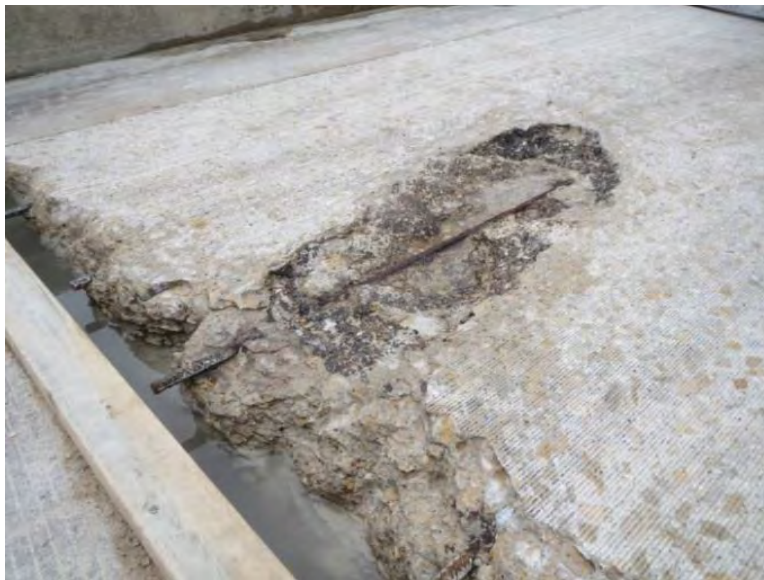
Figure 17. Photo. Distressed region observed on the westbound lane near west abutment prior to installing the UHPC overlay.

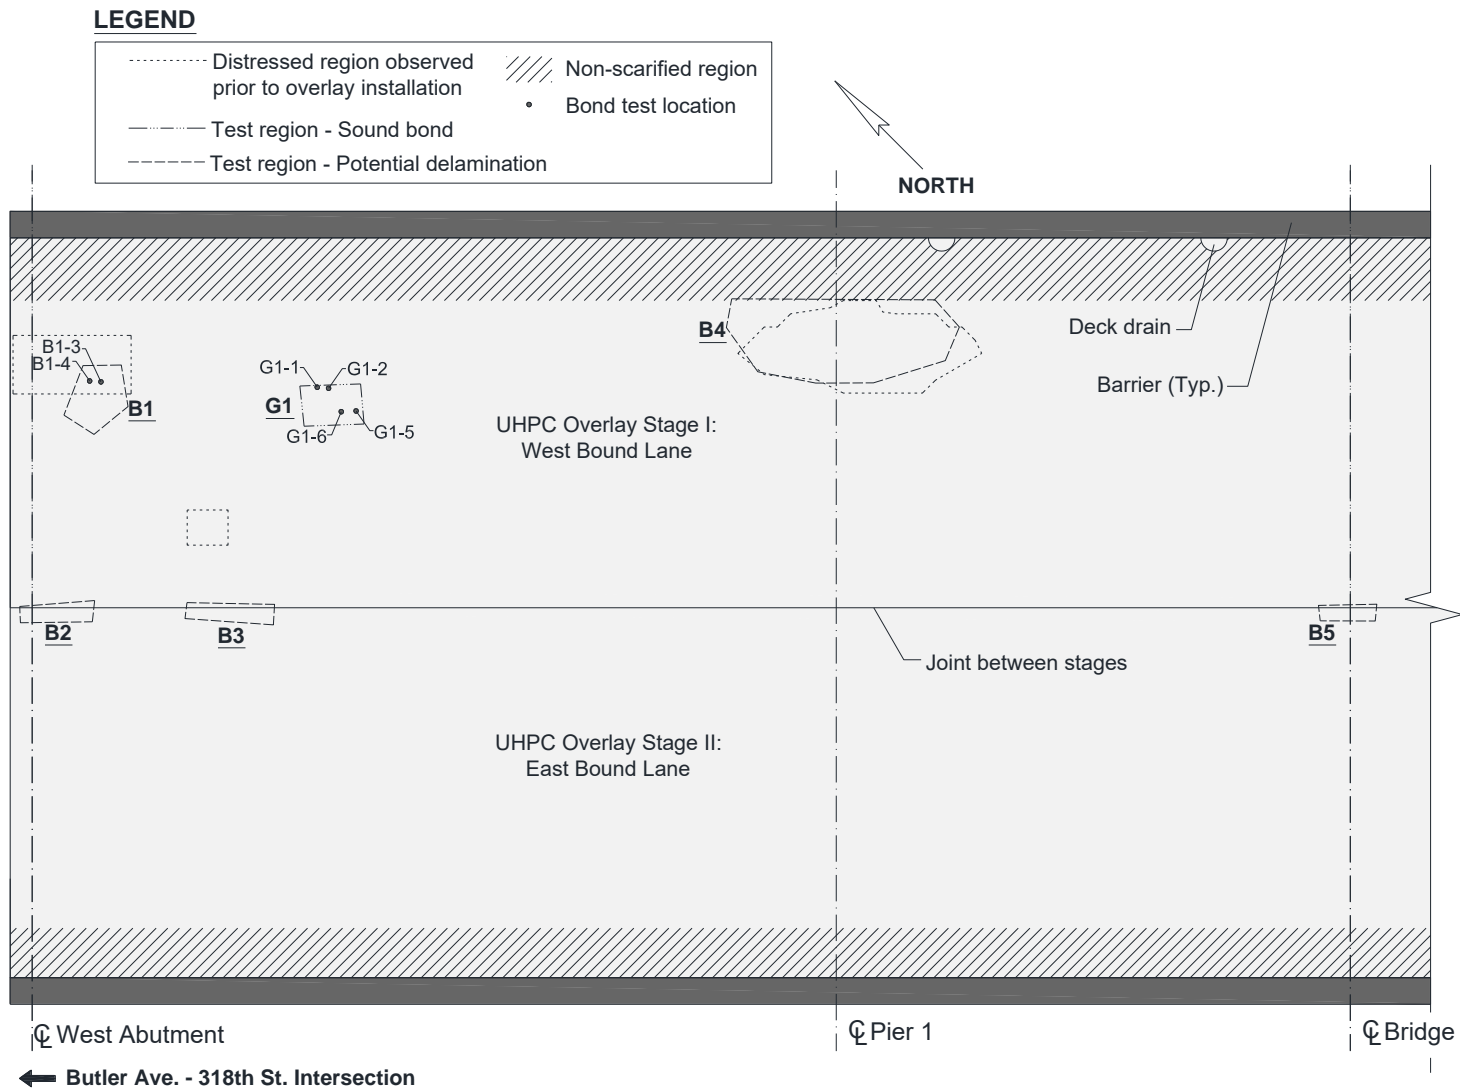
Figure 22 and figure 23 present the observations, inspection findings, and test locations on the western and eastern sides of the bridge, respectively. Moreover, table 4 lists the findings from the onsite chain drag and details related to each region of interest. Regions of good apparent bond are denoted with a “G,” and regions of potential delamination are denoted with a “B.” Regions of potential delamination were found near the boundaries of the overlay construction stage (i.e., at the longitudinal construction joint or near the approaches) or in close proximity to the distressed regions observed prior to installing the overlay.

Figure 22. Illustration. Schematic of observations, inspection findings, and test locations on the western side of the bridge.

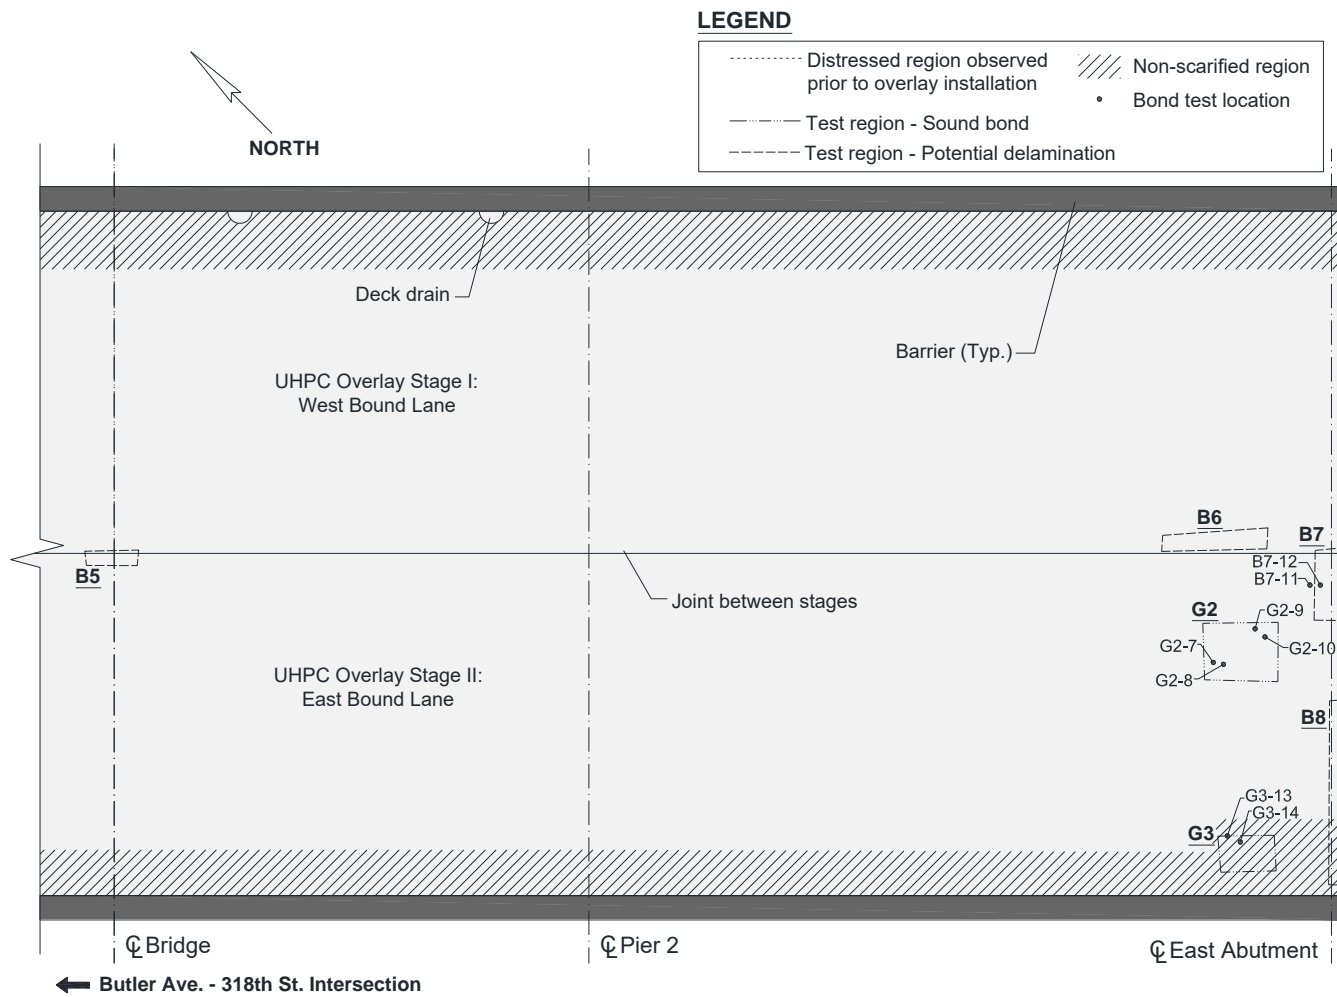
Figure 23. Illustration. Schematic of observations, inspection findings, and test locations on the eastern side of the bridge.

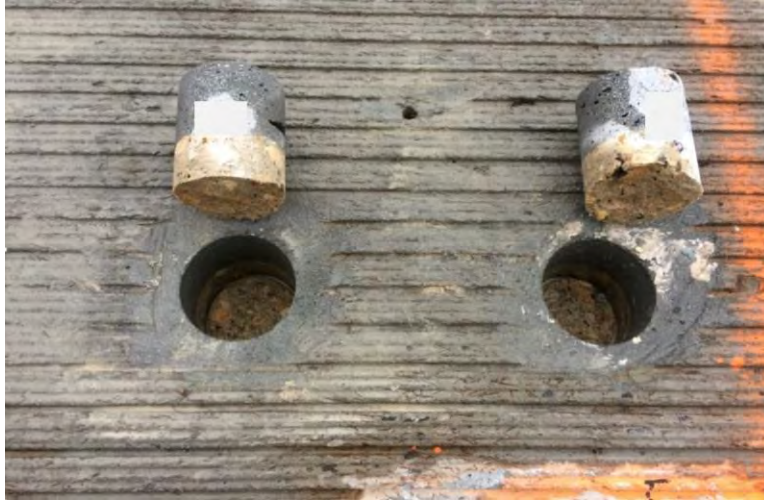
Figure 28. Photo. Two test samples after failure in the substrate concrete.

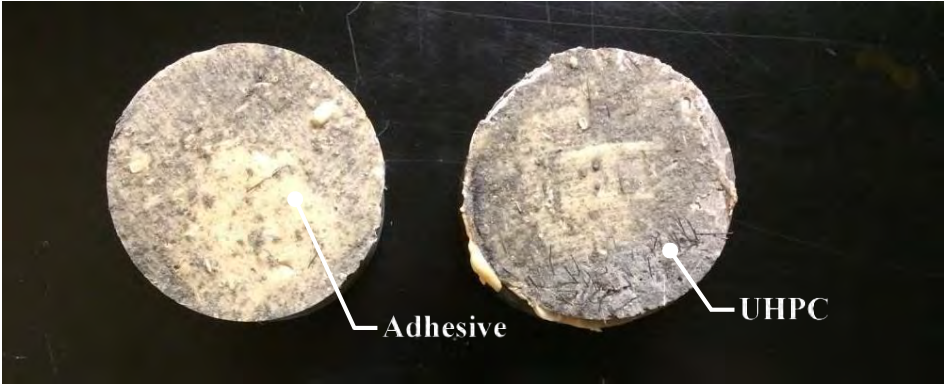
Specimens failing in Mode 4 were subsequently removed from the test location by applying a prying action to the sample using a hand tool. In each case, the prying action resulted in fracture of the substrate concrete. Figure 30 and Figure 31 show a representative sample (G2-9) from the G1 and G2 test locations. The bond between the UHPC overlay and the substrate concrete appears intact.

Figure 30. Photo. Test disc removed from samples from G1 and G2 locations.

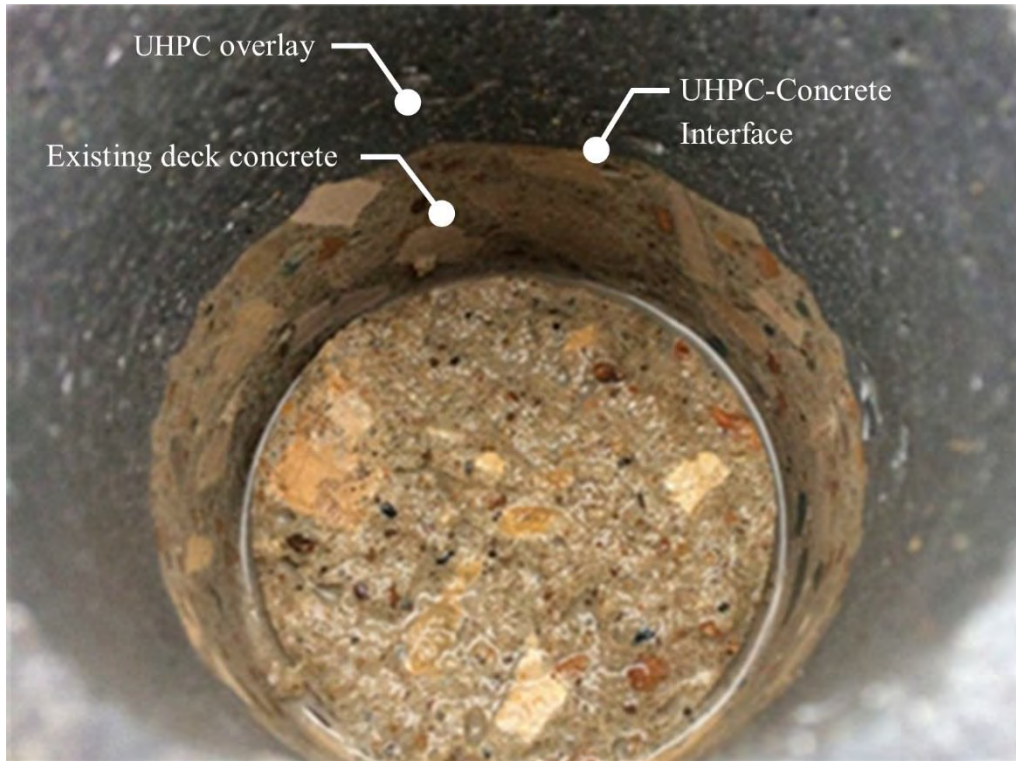
Figure 32 shows the core location from which sample G2-9 was removed. As expected, apparent damage or delamination in the deck concrete or at the UHPC-concrete interface was not present.

Figure 32. Photo. Core location for specimen G2-9.

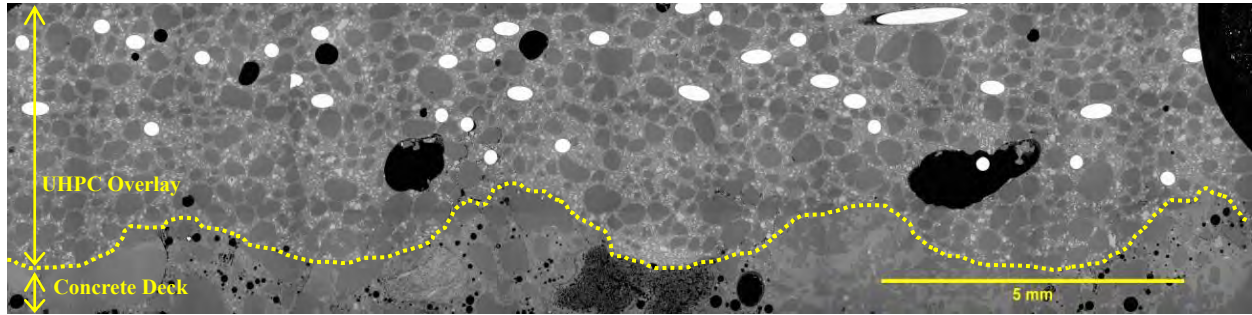
The General map shown in figure 33 displays a sound interface with close physical contact between hydrated phase of UHPC and the existing concrete deck substrate. This observation is justified by the absence of a gap dividing the paste from the concrete substrate and the presence of hydrated cement products—most likely calcium silicate hydrated (C-S-H) and portlandite—on the interface. The high degree of direct contact between the UHPC overlay and the concrete substrates justifies the relatively high tensile stresses sustained during bond strength testing and the absence of failure at the interface. However, this direct contact between hydrated products of the UHPC overlay and the concrete substrate was locally disrupted by the presence of entrapped air, (shown in figure 34) or poor consolidation or accumulation of debris, which is shown in figure 35. The presence of these features near the UHPC-concrete interface was marginal and did not compromise the overall bond performance.

Figure 33. Electron Microscope Image. General map of the UHPC-concrete interface for specimen G2-8.

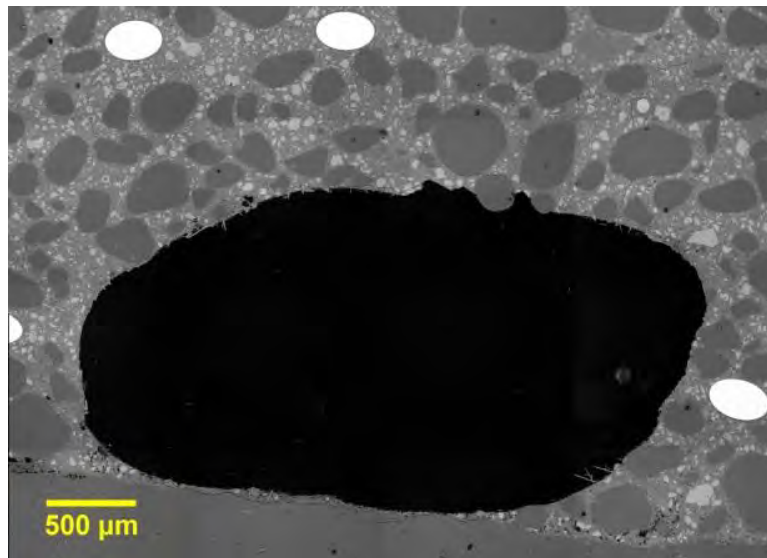
Figure 34. Electron Microscope Image. BSE image of a void between the UHPC overlay and the substrate concrete.

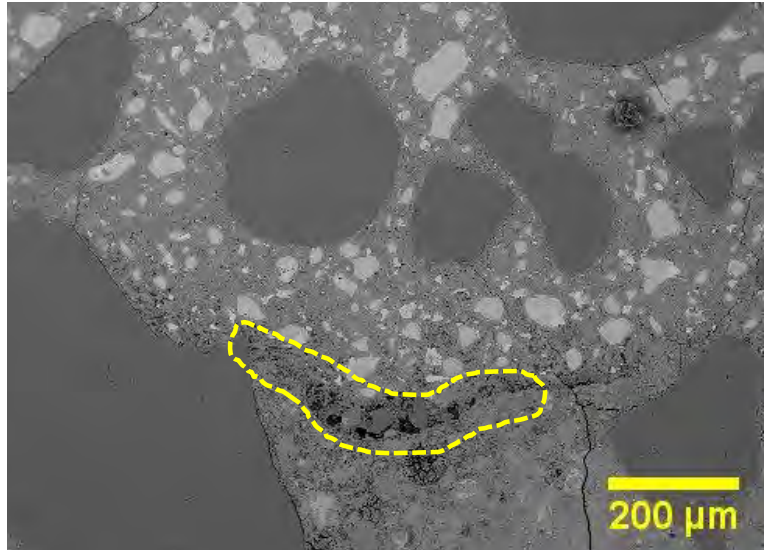
Figure 35. Electron Microscope Image. BSE image of poor consolidation or debris accumulation at the interface.

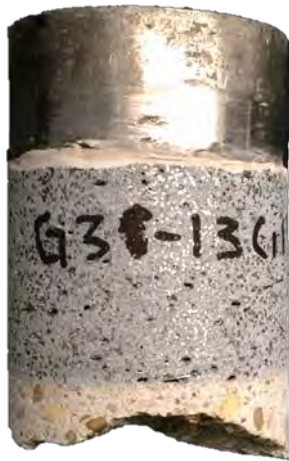
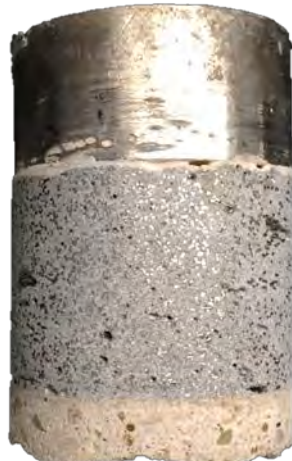
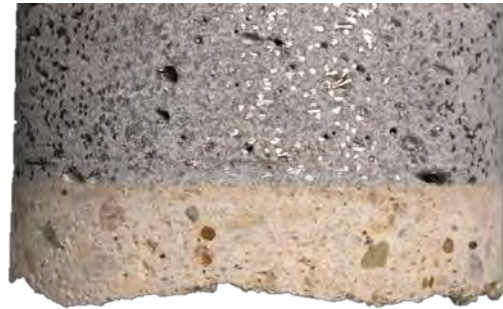
Figure 37. Photos. Specimen G3-13 after testing.

Specimens tested from region G3, which represented an apparent region of good bond without scarification prior to placement of the UHPC overlay, all failed in the concrete substrate (Mode 1). Peak stresses recorded prior to failure were between 344.6 psi (2.37 MPa) and 474.6 psi (3.27 MPa). Figure 37 shows a representative sample (G3-13) from the G3 test location. The bond between the UHPC overlay and the substrate concrete appears intact. Further, the difference in the UHPC-concrete interface texture can be observed when comparing the photos in Figure 31-C and Figure 37-C. Figure 38 shows the core location from which sample G3-13 was removed. As expected, apparent damage or delamination in the deck concrete or at the UHPC-concrete interface was not present.

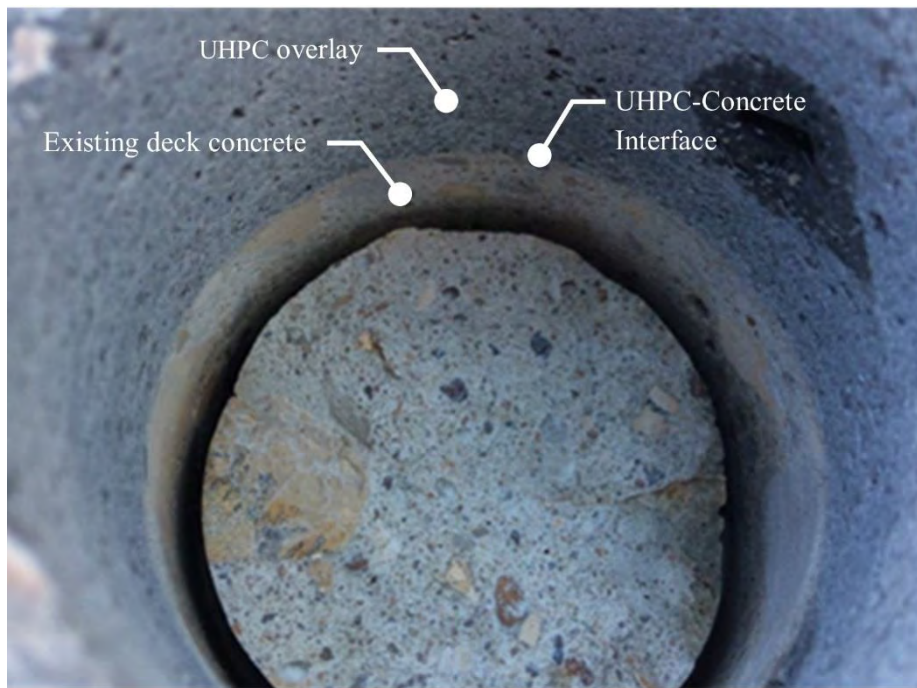
Figure 38. Photo. Core location for specimen G3-13.

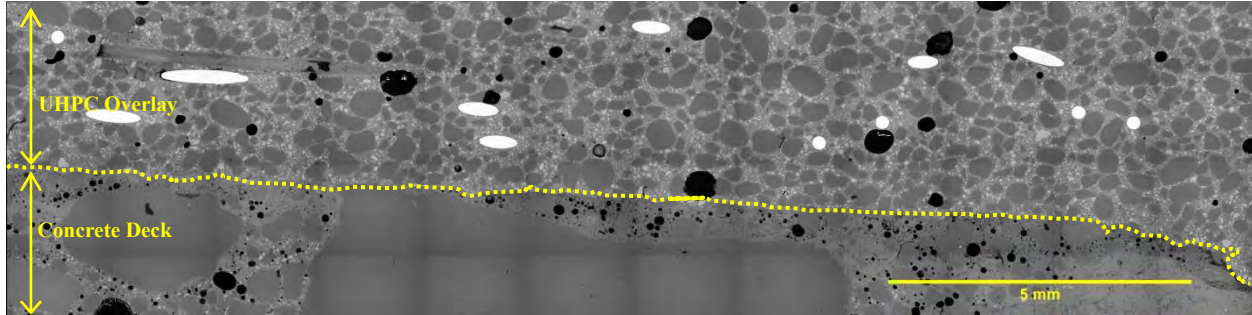
The UHPC-concrete substrate interface of the G3-14 specimen had characteristics similar to those identified on the G2-8 sample. As shown in figure 39, the width of the UHPC paste adjacent to the concrete surface free of steel fibers varied between 0.024 in (0.6 mm) and 0.1 in (2.6 mm). This band was also characterized by its high degree of contact with the concrete surface. This was also motivated by high content of hydrated products of the UHPC paste in the vicinity of the concrete surface.

Figure 39. Electron Microscope Image. General map of the UHPC-concrete interface for specimen G3-14.

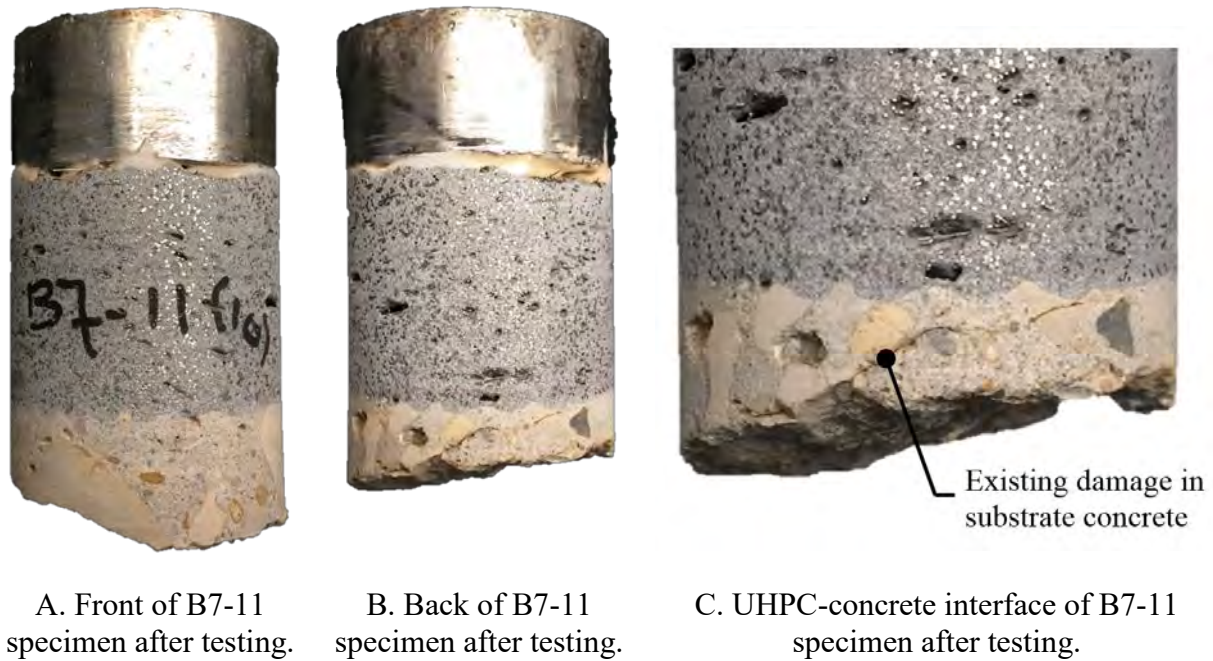
Specimens tested from regions B1 and B7, which represented regions of potential delamination with scarification prior to placement of the UHPC overlay, all failed in the concrete substrate (Mode 1). Peak stresses recorded prior to failure were between 0 psi (0 MPa) and 114 psi (0.79 MPa), which were relatively low compared with other regions. Two of the four samples (B1-3 and B7-12) were loose after completing the coring procedure. These two samples were removed without applying load (i.e., they were loose after completing the particle coring). Further examination of the four test samples and their respective core locations indicated that pre-existing delamination was present in the conventional concrete deck. Figure 41 shows a representative sample (B7-11) from the B1 and B7 test locations. Although the bond between the UHPC overlay and the substrate concrete appears intact, pre-existing damage can be observed within the concrete substrate layer.

Figure 41. Photos. Specimen B7-11 after testing.

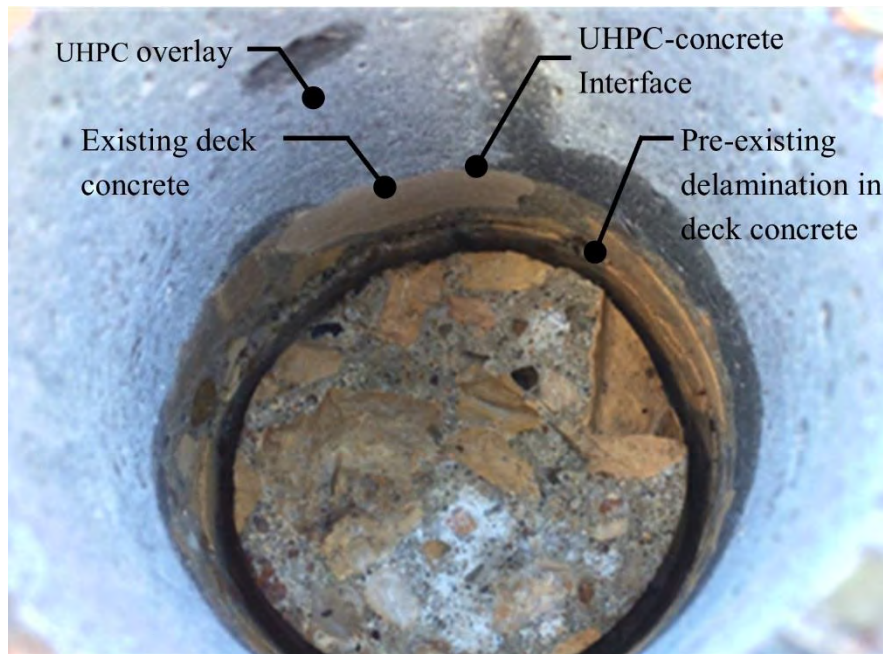
This can be most clearly observed in figure 42, which shows the core location from which sample B7-11 was removed. A horizontal crack plane can be observed within the concrete deck layer approximately 0.5 in (12 mm) below the UHPC-concrete interface. Further, it is evident that when sample B7-11 failed, failure was initiated from this existing crack plane.

Figure 42. Photo. Core location for specimen B7-11.

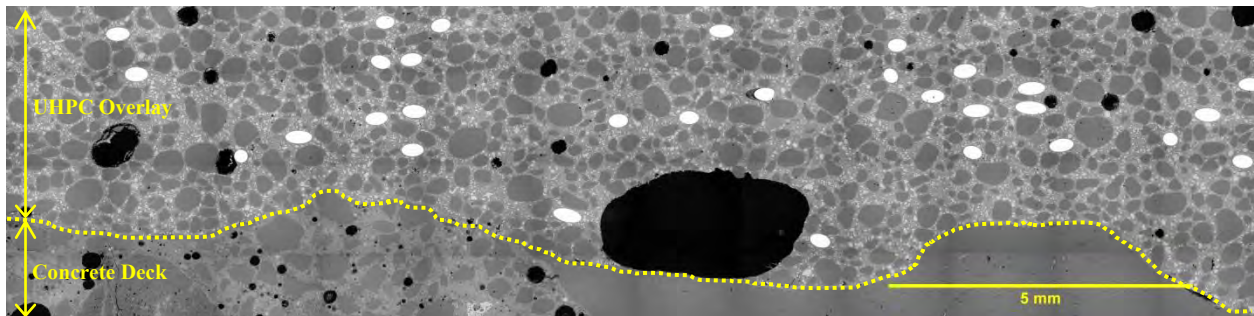
The microstructural analysis of specimen B7-12 also revealed a dense interface dominated by the presence of hydrated products, as in the previous two samples. In this case, the width of the UHPC band without steel fibers ranged from 0.024 in (0.6 mm) to 0.12 in (3.0 mm). The typical valley-hill topography was observed on the concrete surface as illustrated in figure 43. Additionally, as in the case of the G2-8 specimen, entrapped air and accumulated debris were visualized disrupting the contact between UHPC hydrated products and concrete surface. However, the extent of this disruption was limited, and it was not expected to have a deleterious effect on the overall bond strength of the system.

Figure 43. Electron Microscope Image. General map of the UHPC-concrete interface for specimen B7-12.
