PROCEEDINGS

1st Geotechnical Asset Management Peer Exchange (GAMPE) San Juan, Puerto Rico

January 30, 2020

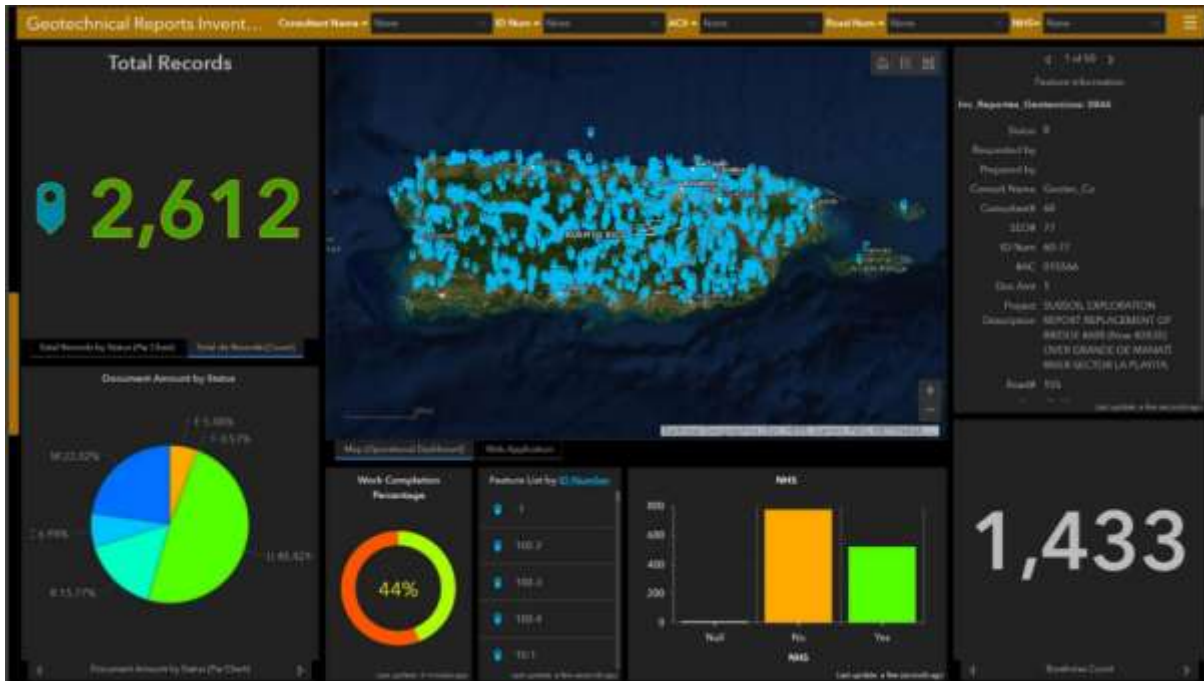
Figure 8: PRHTA SEO GIS-based Geotechnical Reports Inventory dashboard. Source: PRHTA SEO.

Supporting this task are a literature research process, including the *Data Interchange for Geotechnical and Geoenvironmental Specialists (DIGGS)* (5), the *Rockfall Hazard Rating System (RHRS) Participants' Manual* (6), *NCHRP Research Report 903: Geotechnical Asset Management for Transportation Agencies* (7, 8), engagement in the ArcGIS licensing process and acquisition of inspection equipment required for the task. At the time of the exchange, the SEO was confronting the challenge on how to best apply the methodology to rock slopes, along with the overarching challenges associated to Puerto Rico's context: data gaps, geography, geology, topography and climate.

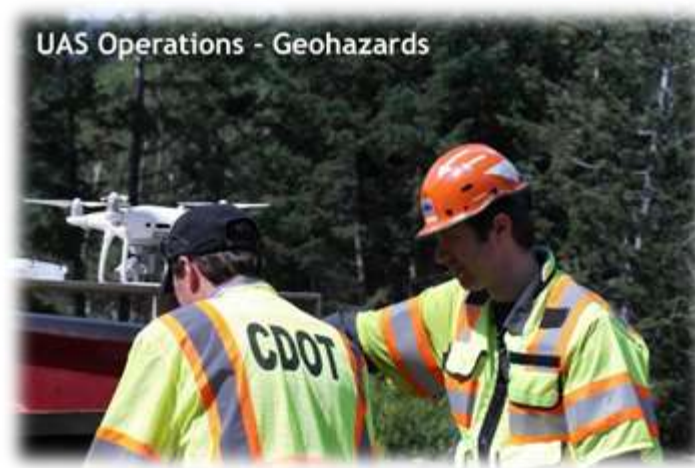
*Figure 12: CDOT makes use of Unmanned Aerial Systems (UAS) as a way to collect terrain data for its Geohazards program.
Source: CDOT.*

The agency has also adopted the latest technology for geohazard reconnaissance and mitigation, in particular LiDAR and photogrammetry systems deployed through Unmanned Aerial Vehicles (UAVs) and land-based systems. These allow for detailed monitoring of mass movements, in which changes are detected between consecutive geomorphologic maps of formations of interest. Small changes of a portion of a slope relative to the main feature thus act to precisely delineate landslide and rock fall blocks.

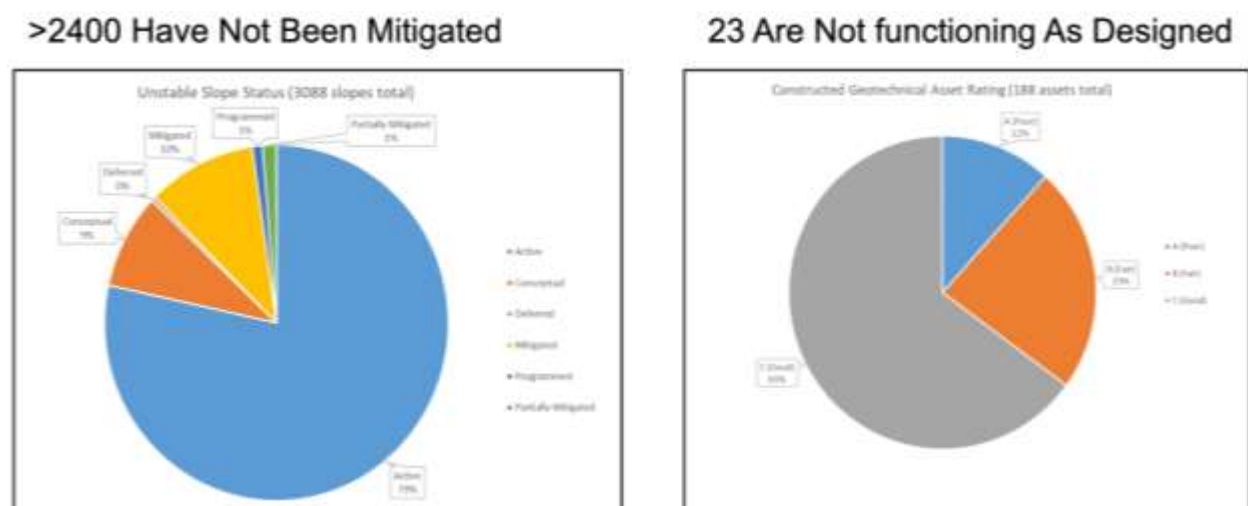
Figure 16: Mitigation status and condition of WSDOT geotechnical assets. Source: WSDOT.

WSDOT also developed its Unstable Slope Rating form, a document used to evaluate and prioritize slopes for geotechnical interventions. The form contains ten items, including the slope characteristics, mass movement characteristics, traffic characteristics, history of problems and maintenance costs. Each item is rated from 1 to 5 in terms of likelihood and consequences associated to the slope's instability, potential impacts to traffic and asset condition, which are then combined into a risk-based matrix. The total score applicable to each slope is added up and compared to various condition assessment thresholds. Elements rating below 250 are classified as "good", from 250 to 299 classifies as "fair" and from 300 onwards classify as "poor". In addition, the four main types of constructed geotechnical assets are classified according to their operational status and maintenance needs, with elements working well and in no need of maintenance actions classified as "good", those needing minor maintenance as "fair", while those needing major maintenance, reconstruction and/or not functioning as designed are rated "poor".

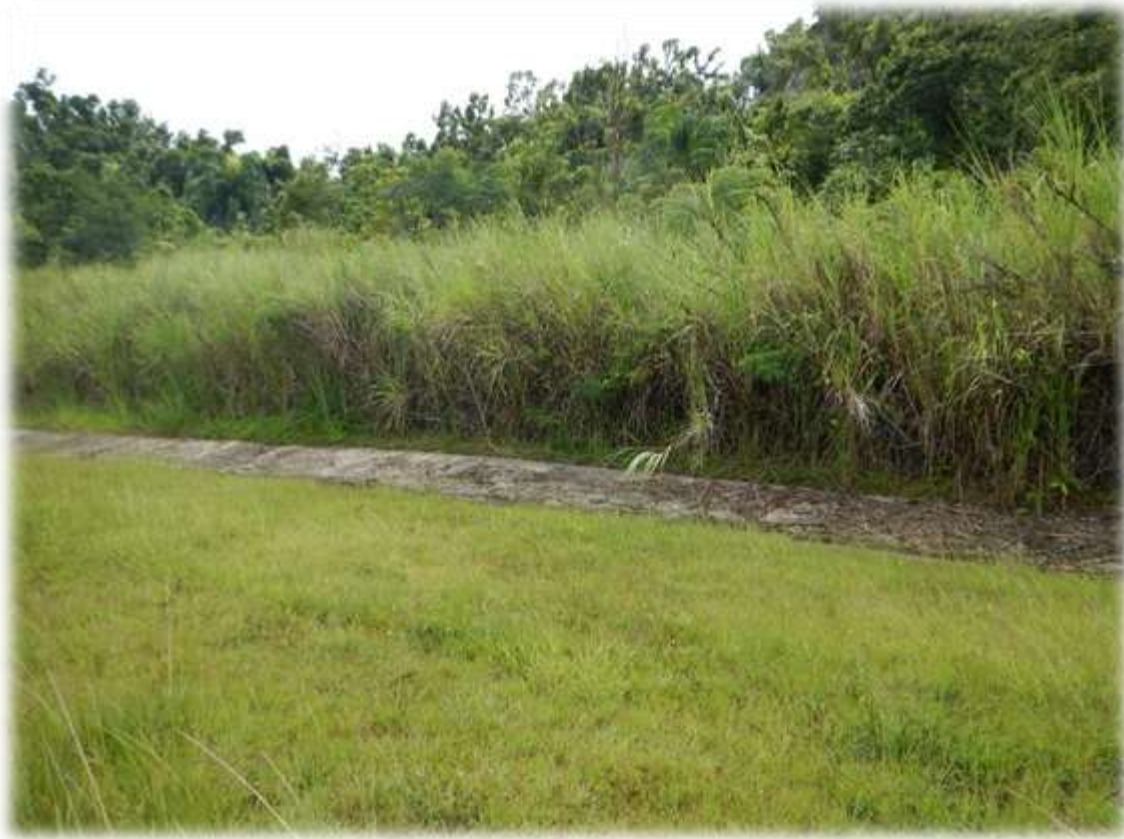
Figure 26: Drainage ditch between filled sinkhole (short grass) and the surrounding natural terrain (tall grass) at PR-10 cuts (image: Douglas A. Anderson, FHWA Federal Lands).

The site in question is located at km 57.2, within the Río Abajo State Forest, a natural preserve administered by the Department of Natural and Environmental Resources (DNER), and traversing limestone belonging to the Montebello Member of the Cibao Formation. This site was selected because it features an unconventional geotechnical asset: a sinkhole with a free-draining fill material. One of the requirements for PR-10's construction was the preservation of karst hydrology, which largely relies on groundwater drainage entering through sinkholes. PRHTA thus had to provide a special fill design capable of both supporting the roadway and its traffic, while at the same time being able to maintain the full drainage capacity of the original sinkhole. This special fill consisted of clearing and grubbing the walls of the sinkhole, which were then lined with a geosynthetic drainage layer, filled in with coarse aggregates and vertical drains, over which the pavement structure and surface drainage elements were installed.

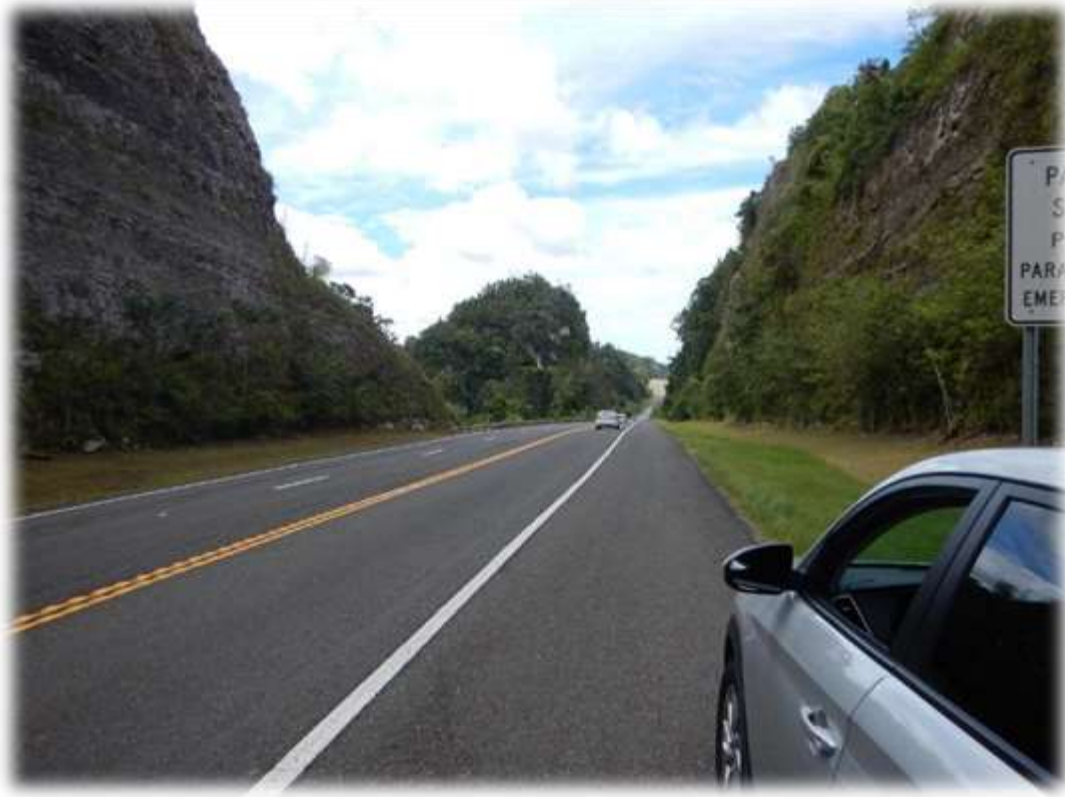
Figure 27: View along PR-10, showing the travel lanes, shoulder, roadside and rock cuts (image: Douglas A. Anderson, FHWA Federal Lands).

Group discussions highlighted how highway cross-section design practices differ between PRHTA and the other participating DOTs. Along NHS highways, PRHTA generally provides a wide clear zone which acts as a mass movement material catchment area, helping mitigate impacts from smaller magnitude events and providing space for realignments in case of major mass movement occur. This was the case of Site 2, which required a highway realignment when the slope underlying PR-10 began failing during the decade following its construction.

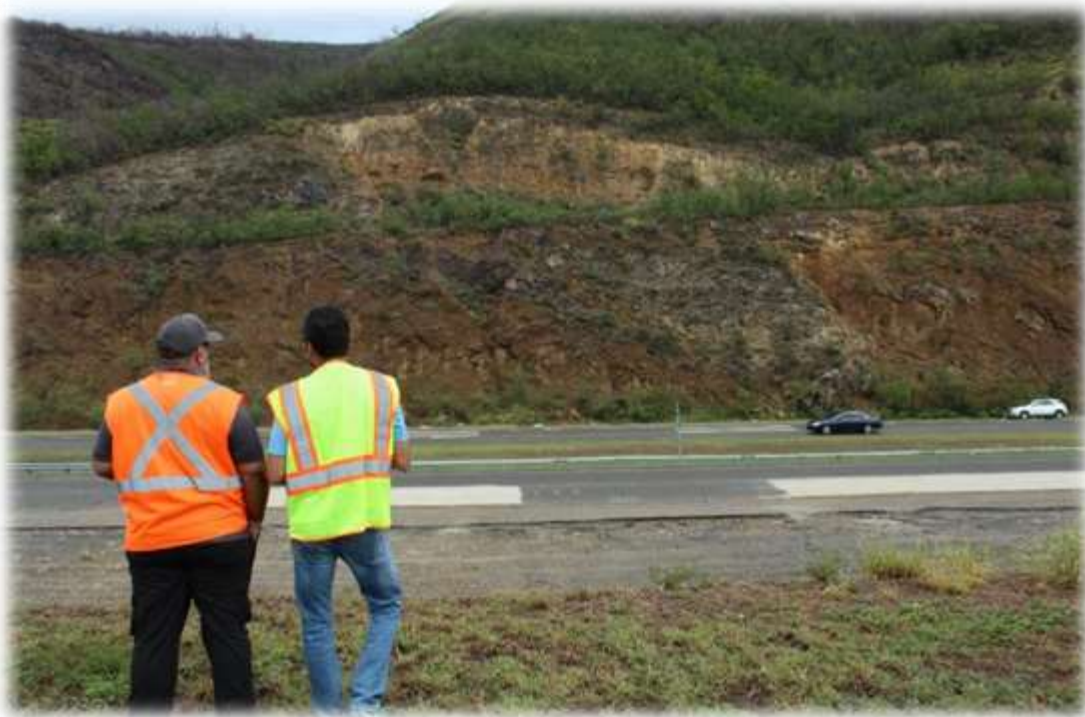
Figure 28: Benched rock cut along PR-52, km 68.3. Wildfire remnants can be observed towards the upper left side of the image, along with the semiarid climate vegetation cover, consisting of grasses, cacti and shrubs.

The full group attended and traveled from the PRHTA SEO in Bayamón to the municipality of Salinas, located in the semiarid southern coast of the Island. The fourth site of interest, located in km 68.3 at the western side of Salinas, consists of a benched rock cut of the Cuevas Limestone formation along the Esmeralda fault line. Contrasting with the limestone formations at the Río Abajo State Forest, rock at this site has degraded more and thus the slope generates more rock fall events. These characteristics have resulted in a slope rating of A, as per the RHRS methodology.

Between 2011-2020, the east and south areas of Puerto Rico have experienced abnormally dry weather, including a major drought event in 2015 and numerous wildfires since. These wildfires have burned and scorched the vegetation of the area, damaging the root system holding together the soils. Additionally, thermal stresses induced by the fire cause expansion and fragmentation of soil and rock particles, further increasing propensity to earth mass movements. These mass movements, consisting mainly of rock falls and debris flows, threaten intercity traffic consisting of an ADT of 35,000 and trucks carrying imported goods from San Juan to the nearby city of Ponce and the more distant city of Mayagüez in western Puerto Rico. At the time of the site visit, no protection beyond modular concrete barriers was provided at this slope.

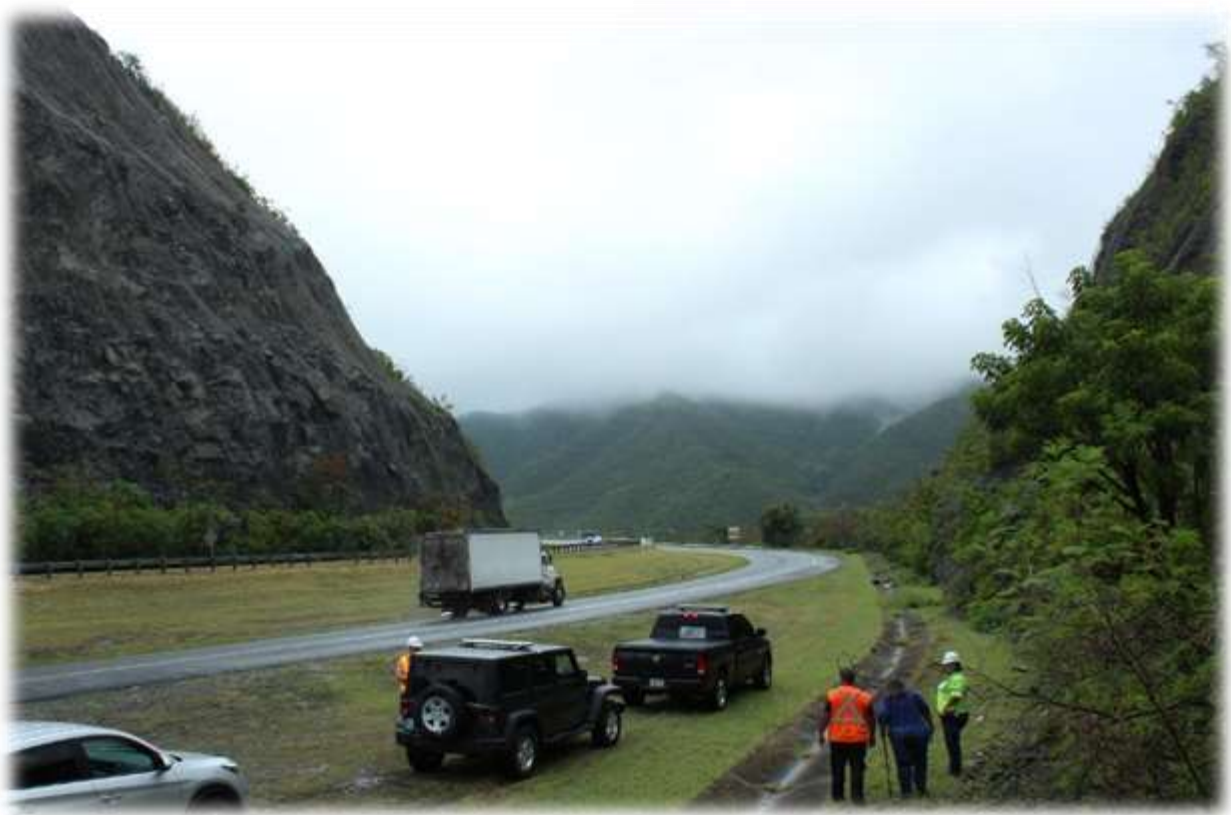
Figure 30: View of Site 5, with the relevant slope to the left. Notice how the clear zone opposite to the slope exceeds 10 meters (33 feet) of width between the shoulder and the forested area, while the clear zone at the toe of the slope can barely be distinguished.

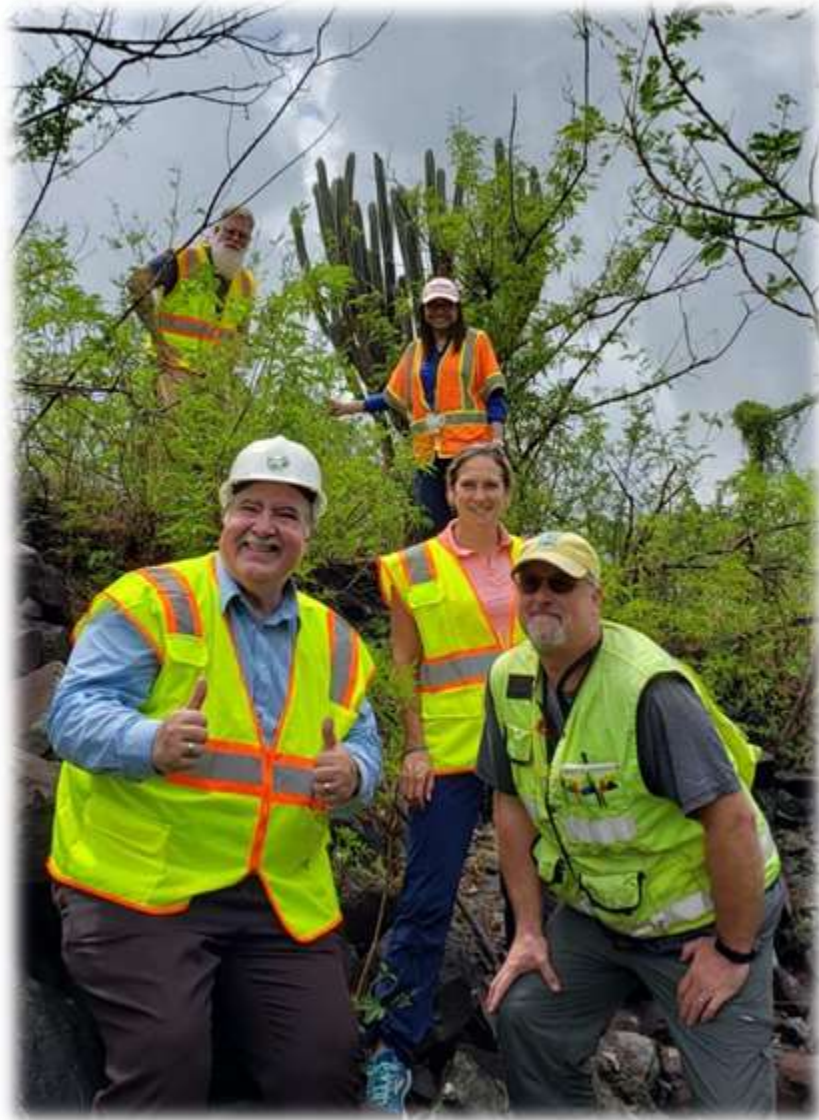
Figure 31: Roadside vegetation at PR-52, Km. 68.3, representative of semiarid slopes in southern Puerto Rico, consisting of cacti, shrubs and grasses. From top to bottom: Engineering Geologist Marc Fish (WSDOT), Eng. Cecilia Barbosa (PRHTA), Engineering Geologist Krystle Pelham (NHDOT), Engineering Geologist Douglas A. Anderson (FHWA Federal Lands) and Dr. Benjamín Colucci (PRLTAP).

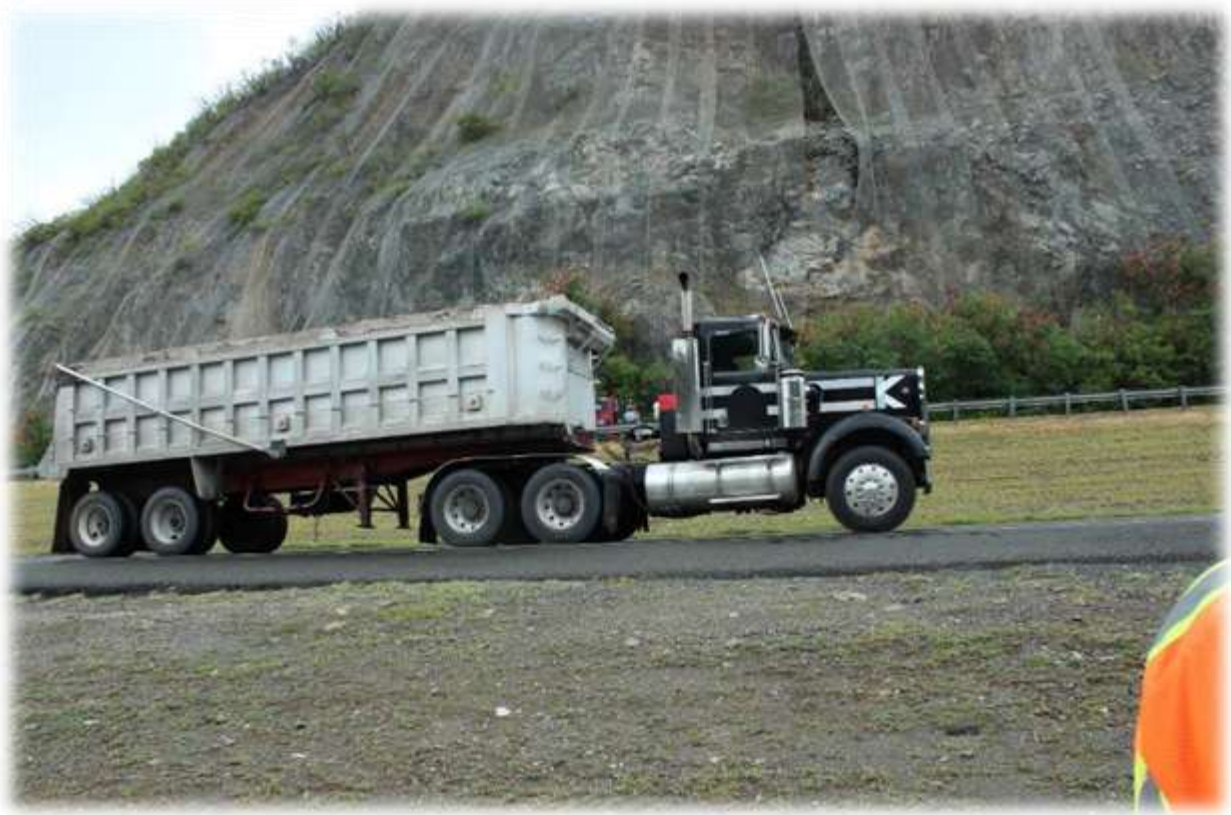
Figure 32: View of slope covered in steel mesh with a torn seam, along with a typical heavy vehicle traversing PR-52 northbound.

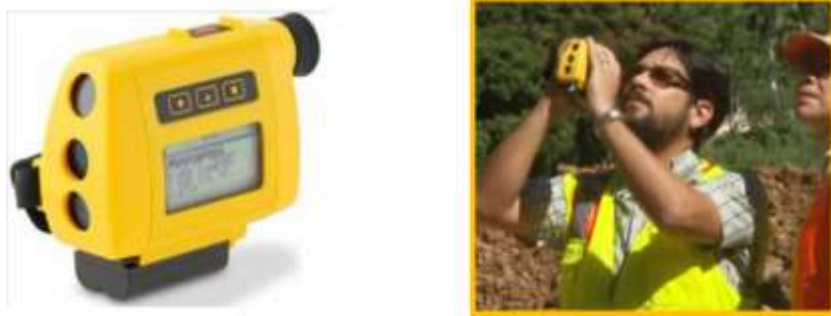
Figure 36: Rangefinders are a small and portable tool which aids in the measurement of roadside slopes. Source: PRHTA.
