TECHNOTE

Ultra-High Performance Concrete for Bridge Deck Overlays

FHWA Publication No.: FHWA-HRT-17-097

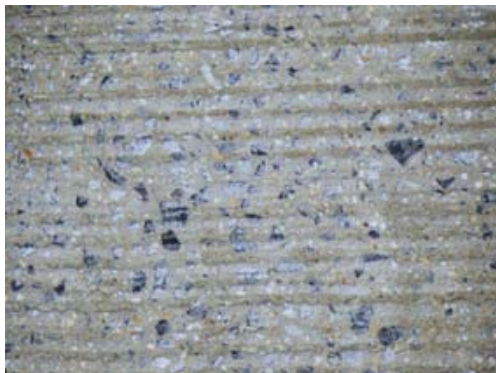
3/4 inch (19 mm). In this study, scarification was achieved using a small-scale walk-behind scarifier to remove approximately 3/8 inch (9.5 mm) of substrate material. Figure 2 shows a picture of the concrete substrate base slab after scarification. A series of grooves can be observed along with some of the concrete's internal coarse aggregate. Hydrodemolition uses high-pressure (up to 45,000 psi (310 MPa)) water jetting to remove material from the substrate in a controlled manner. In this case, a pressure of 15,000 psi (103 MPa) was used to remove 1/2 inch (12.7 mm) of the substrate material. Figure 3 shows a photo of the post-hydrodemolition concrete substrate base slab used in this study.

Figure 2. Concrete substrate surface prepared using scarification.

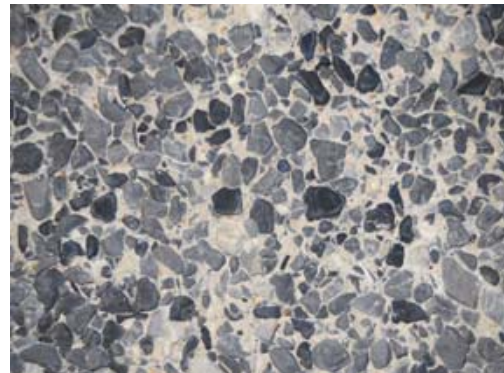
Figure 3. Concrete substrate surface prepared using hydrodemolition.

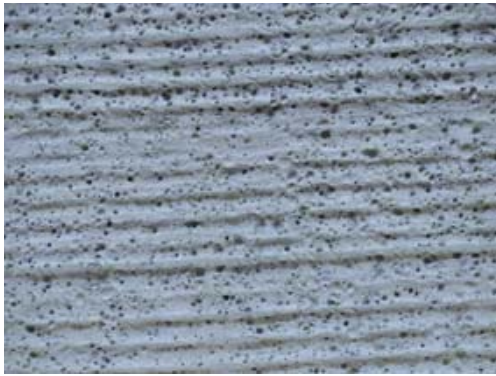
a commercially available UHPC-class material commonly deployed in prefabricated concrete bridge deck connections. One of the UHPC base slabs was prepared using scarification to remove approximately 3/8 inch (9.5 mm) of substrate material (shown in figure 4), and the other one was prepared using hydrodemolition with a pressure of 40,000 psi (276 MPa) to remove 1/2 inch (12.7 mm) of the substrate material (shown in figure 5).

Figure 4. UHPC substrate surface prepared using scarification.

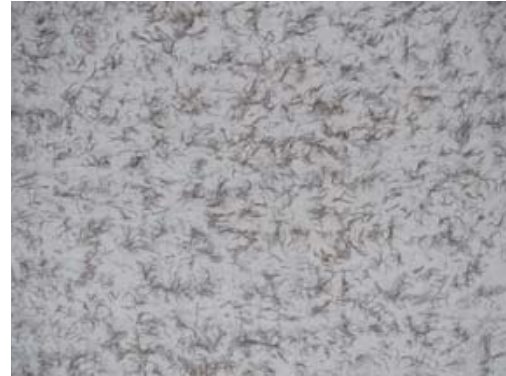
Figure 5. UHPC substrate surface prepared using hydrodemolition.

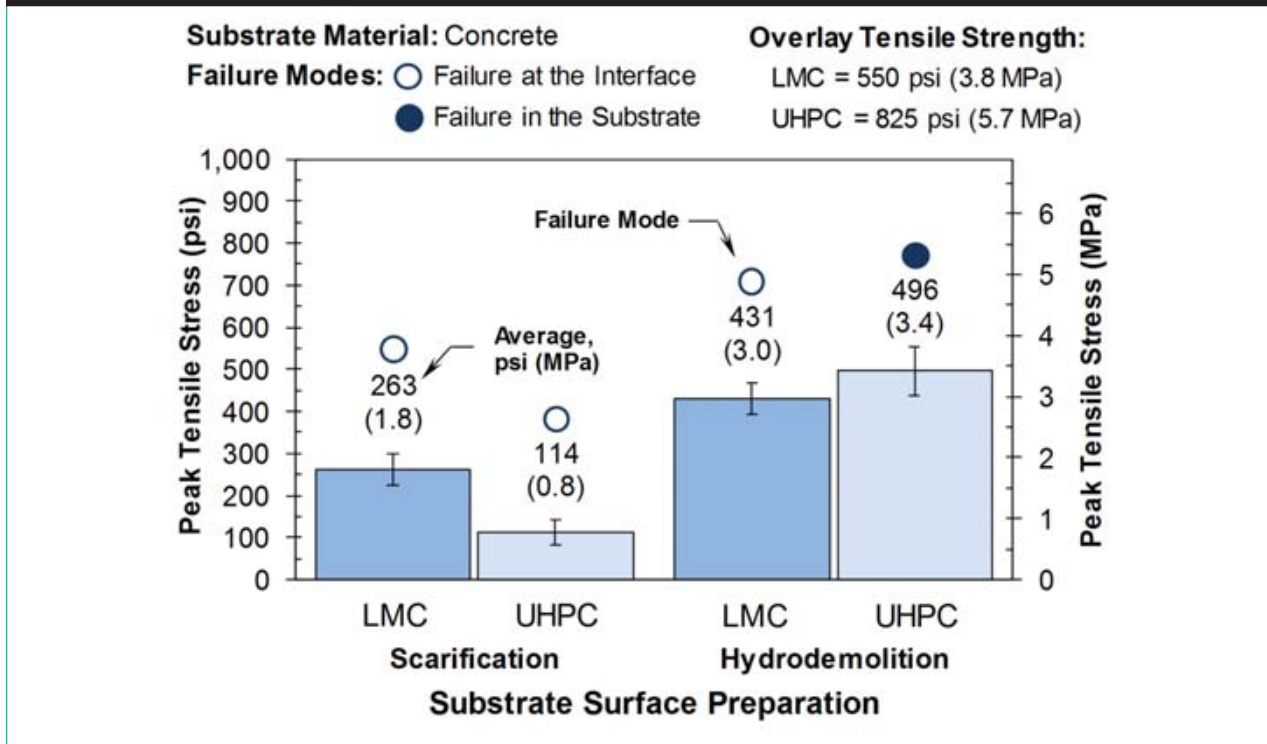
Figure 6 and figure 7 present the peak tensile stresses at failure of the overlay materials cast over concrete and UHPC substrates, respectively. In general, UHPC overlays exhibit comparable, if not higher, bond strengths than LMC overlays, except for the case where a scarified concrete substrate was used. Another observation is that bond strengths tended to

be higher when a UHPC substrate was used, compared to those obtained over a concrete substrate. Finally, the hydrodemolition technique offers the possibility of obtaining higher bond strengths than scarification. This is attributed to the fact that mechanical preparation methods may introduce microcracking on the substrate material, which might eventually affect the bond performance.

Figure 6. Peak stresses recorded from direct tension bond testing on a concrete substrate.

The laboratory investigation described in this report resulted in comparable, if not better, bond performance of UHPC overlays compared to that of LMC overlays, making it possible to think about the potential use of UHPC overlays in bridge decks. It can also be concluded that the type of substrate material influences the bond strength, as the UHPC substrate exhibited higher bond strengths than concrete substrates.

Likewise, the substrate surface preparation method seems to be important to obtaining good bond. The substrate surfaces treated with hydrodemolition resulted in higher bond strengths than those obtained on a scarified substrate surface.

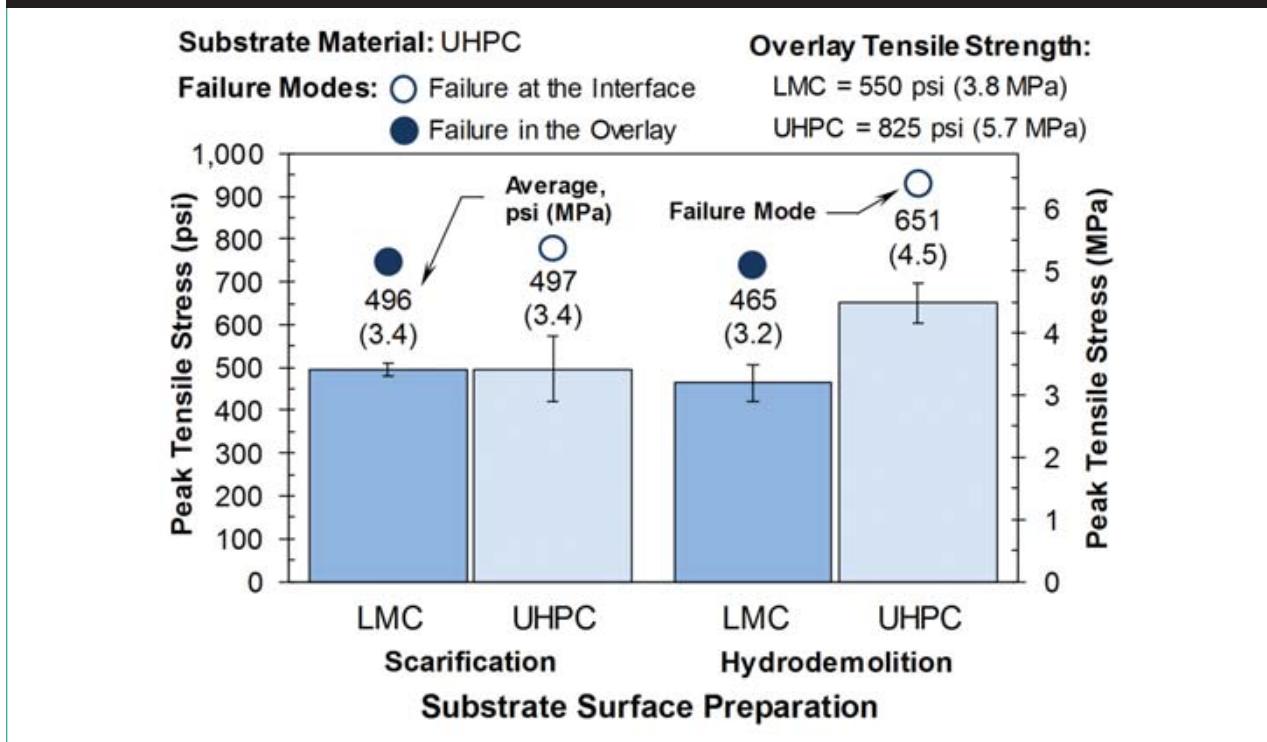
Figure 7. Peak stresses recorded from direct tension bond testing on a UHPC substrate.

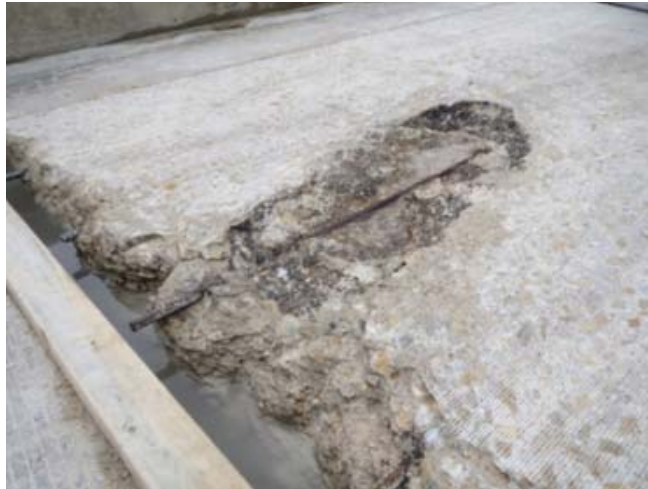
The bridge deck was beginning to exhibit delamination and spalling along the curbline nearest the deck drains and at each end at the expansion joints. It is likely that the deterioration was related to chloride laden water ingress into the concrete and past the strip seal expansion joints, leading to reinforcement corrosion and freeze-thaw cycle-related distress. For example, figure 8 shows one of the distressed regions found on the deck after removing a thin layer of cover concrete. This region was selected as a test location. As shown, this deterioration had progressed to the point that maintenance actions were necessary. A UHPC overlay solution was selected to repair the deteriorated deck. This project was considered a demonstration project for UHPC overlays.

Figure 8. Distressed region on the westbound lane near the western abutment: test region B1.⁽²⁾

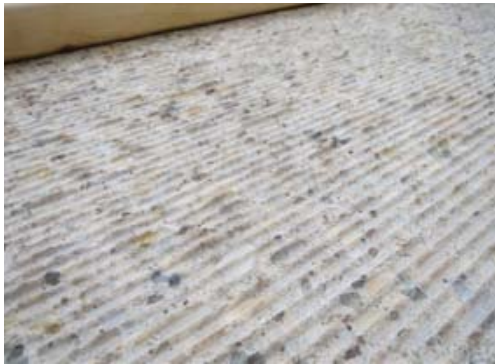
Figure 9. Deck surface after diamond grinding.⁽²⁾

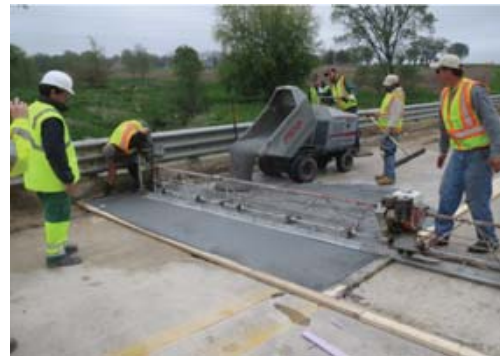
The UHPC overlay material used was proprietary, and the material supplier provided onsite technical support to the contractor during the installation of the overlay. The overlay was constructed in two stages. The overlay was first installed on the westbound lane (stage I) and subsequently on the eastbound lane (stage II). Prior to installation, the deck surface was prepared with a truck-mounted diamond grinder to promote bonding with the UHPC overlay (shown in figure 9). The diamond ground concrete deck was pre-wetted a few hours before placement of the overlay. The UHPC overlay was mixed onsite and placed using motorized buggies and hand tools (shown in figure 10). Once completed, the overlay surface was coated with a wax-based curing compound and covered with plastic sheeting to prevent dehydration.

Figure 10. UHPC overlay installation on the westbound lane.⁽²⁾

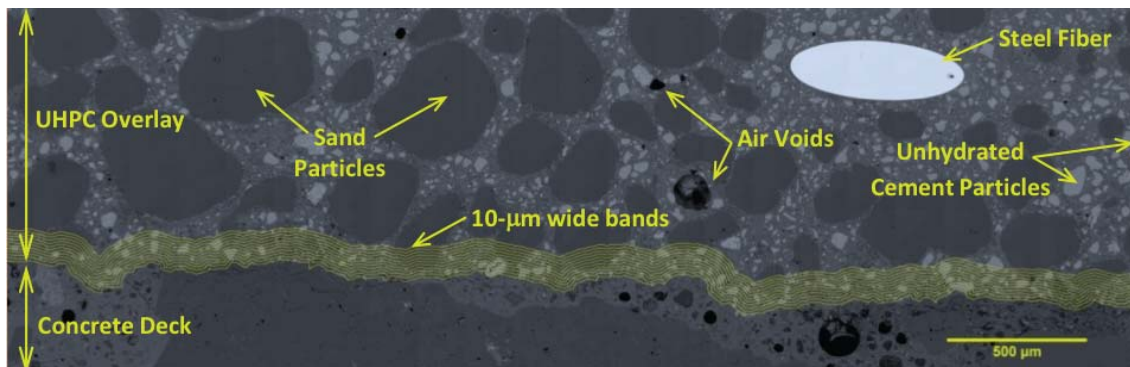
Select specimens, noted in table 3, were subject to microstructural analysis using a SEM. The goal of this analysis was to quantify the integrity of UHPC at the microstructural level. This analysis was conducted using an FEI Quanta 650 SEM equipped with a concentric backscatter detector. Large backscatter electron mapping areas were collected using AZtec 2.4 energy dispersive spectroscopy (EDS) micro-analysis software. The interface was mapped in consecutive 10- μ m wide bands (shown in figure 11), starting from the location where the UHPC cement paste contacted the concrete deck substrate. This analysis was conducted 10 times, moving backward into the bulk of the UHPC paste (100- μ m away from the interface line). This

process was previously used by Beushausen, Höhlig, and Talotti (2017) to characterize the microstructure of bonded concrete overlays and is currently being used by researchers at TFHRC to characterize bond between fresh cementitious materials and existing concretes.⁽¹¹⁾ This analysis provided a quantitative measure of the porosity, aggregate, hydration products, and unhydrated cement particle content near the interface.

Figure 11. Composite SEM micrograph used for microstructural analysis.⁽²⁾

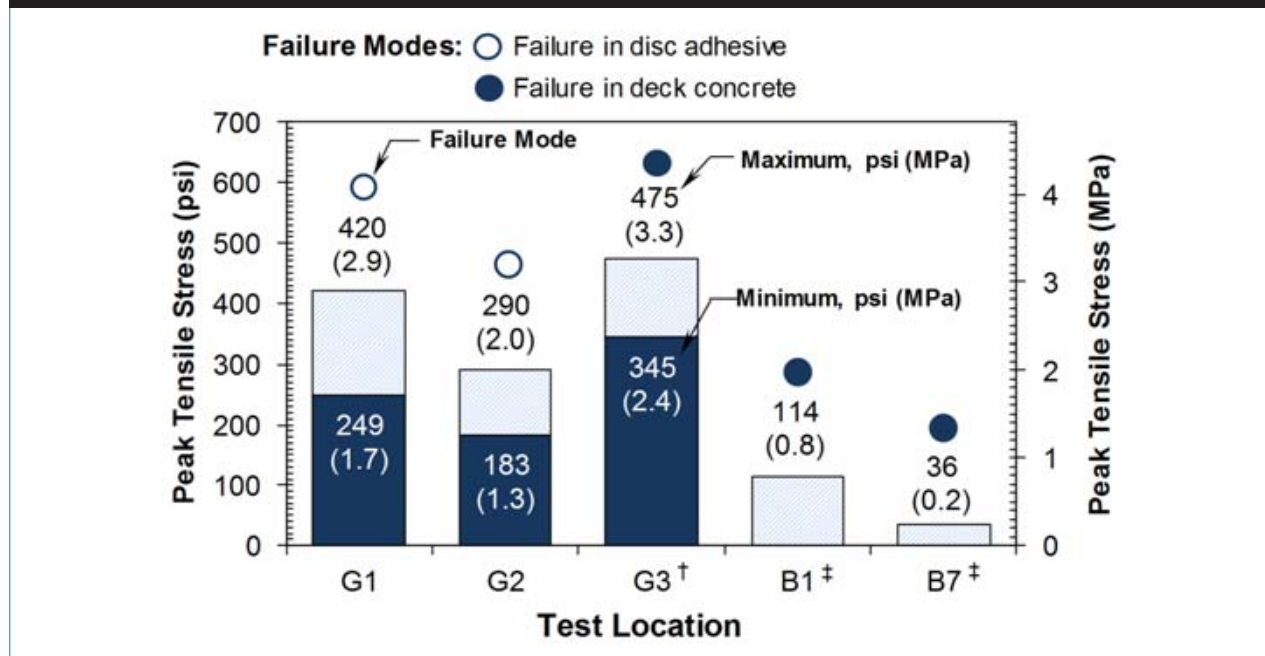
Figure 12 presents the peak tensile stresses captured during direct tension pull-off testing at the five different test locations. This graph reports the minimum and maximum stresses recorded along with the failure mode exhibited by each specimen group.

The results indicated a good bond between the UHPC overlay and the substrate concrete deck with and without diamond grinding. The peak tensile stresses sustained by specimens in regions G1, G2, and G3 prior to failure were comparable to, if not higher than, the bond strengths of other UHPC-class materials (nonthixotropic) bonded to a roughened concrete substrate.⁽¹²⁾ Furthermore, the peak tensile stresses sustained by these specimens were, in most cases, higher than those exhibited by conventional grout-like materials bonded to a roughened concrete substrate.⁽⁶⁾ For the locations with potential delamination (B1 and B7), pull-off

Figure 12. Peak stresses recorded from direct tension bond testing.

[†]Concrete deck at this location was not diamond ground prior to overlay installation.

[‡] Minimum peak stresses were zero at these locations; damaged deck concrete was present.

test specimens failed in the substrate concrete at relatively low stresses. Some specimens tested at these locations did not hold any load at all. Instead, these specimens could be removed from their core locations by hand, indicating existing damage in the substrate concrete layer.

that the bond between the UHPC overlay and the existing concrete bridge deck was intact. Mechanical testing verified that the locations suspected of having good UHPC–concrete bond were able to carry relatively high tensile stresses without bond failure. It can also be concluded that good bond was achieved even at locations where deck concrete was not roughened prior to placement of the UHPC overlay; however, this is dependent on the surface quality of the substrate concrete and is not a recommended practice. The two test locations suspected of delamination were indeed found to have delaminated concrete. However, delamination was preexisting within the deck concrete and was likely present prior to placement of the UHPC overlay.

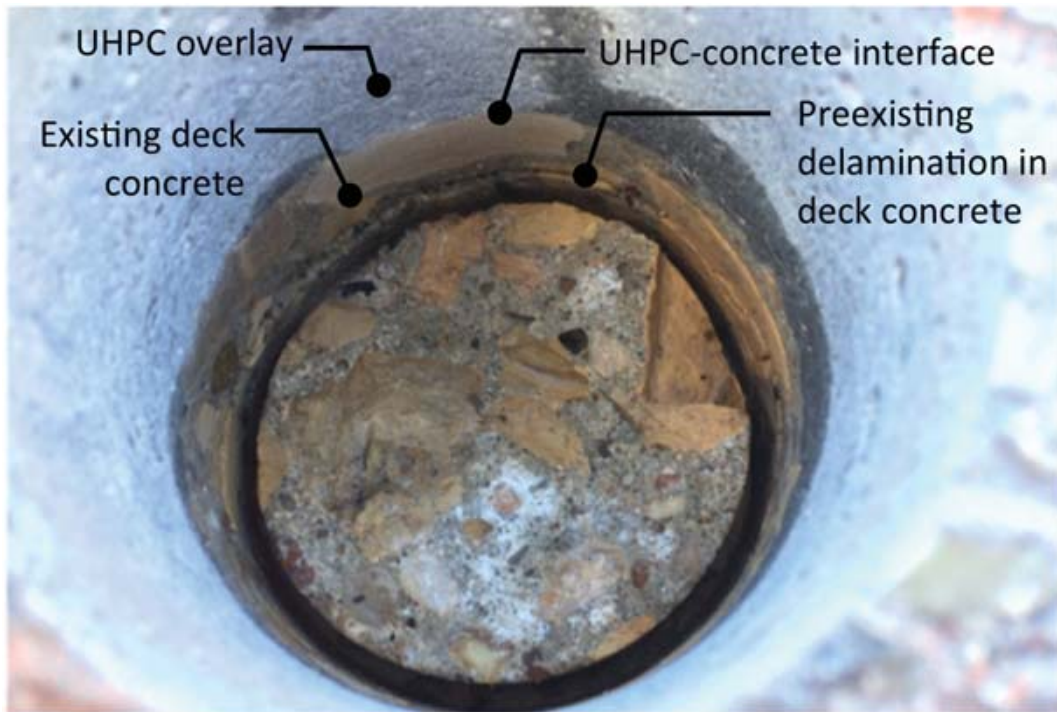
Figure 14. Photo of B7 test location after core removal.⁽²⁾

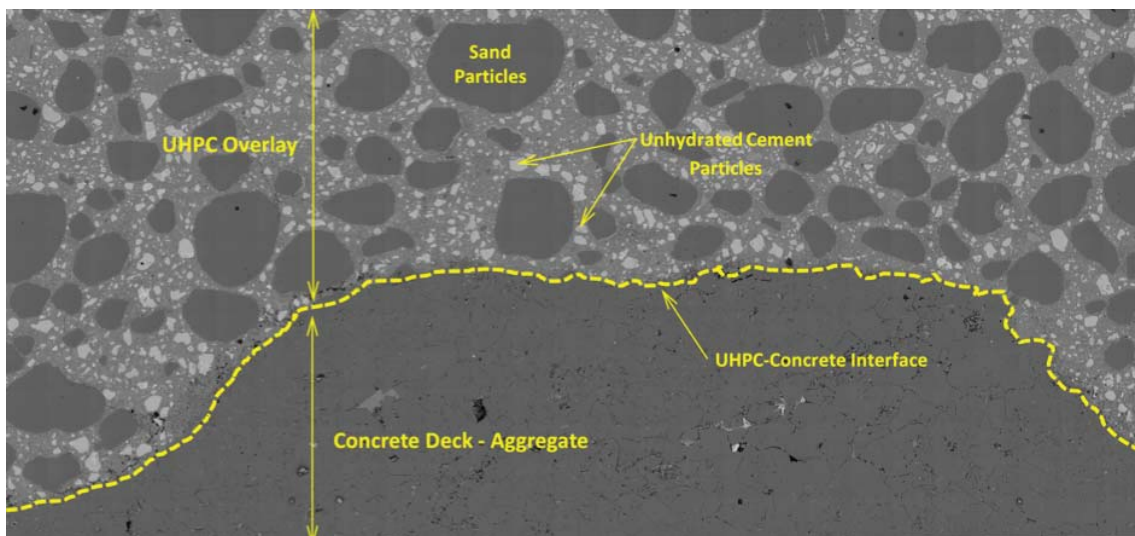
SEM revealed that the UHPC–concrete interface regions were very much intact. Furthermore, the SEM investigation revealed that the UHPC overlay was well-consolidated along the interface line. This can be observed in figure 15, which depicts a SEM micrograph of a sample taken from test location B7. This image

is representative of test location B7 along with the other two test locations analyzed with the SEM, G2 and G3. It can be observed that there is no apparent void space (porosity) between the interface line and the UHPC overlay. Using the AZtec 2.4 EDS microanalysis software, the material contents located along the interface line were quantified.⁽¹³⁾ A portion of these results are presented in figure 16, which shows the hydration products, unhydrated cement, and porosity of the UHPC overlay 10- μm from the interface line. Figure 16 shows that, for all three test locations analyzed, UHPC hydration products were the principle phase present. This indicates good consolidation and bond at the interface location. In contrast, unhydrated cement particles and void space contents were nearly absent. As a point of comparison, figure 16 shows a set of data collected by De la Varga et al. (2017), which is denoted “non-shrink grout.” The data was collected near the interface line between a roughened concrete surface and a non-shrink grout overlay. Analysis shows a high concentration of unhydrated products and porosity, which has a deleterious impact on bond strength.⁽¹¹⁾

Figure 15. SEM micrograph from a sample taken from test location B7.

Visual inspection of the UHPC field specimens' interface indicated, in all cases, that the interface between the UHPC overlay and deck concrete appeared intact. This was further investigated through microstructural analysis using a scanning electron microscope. Microstructural analysis revealed that there was a high density of UHPC in direct contact with the concrete substrate surface. This high density was caused by the high content of hydration products from the UHPC and low porosity adjacent to the interface. The consequence of this was a high degree of direct contact between the UHPC and the concrete surface, which translated into high tensile strength of the interface.

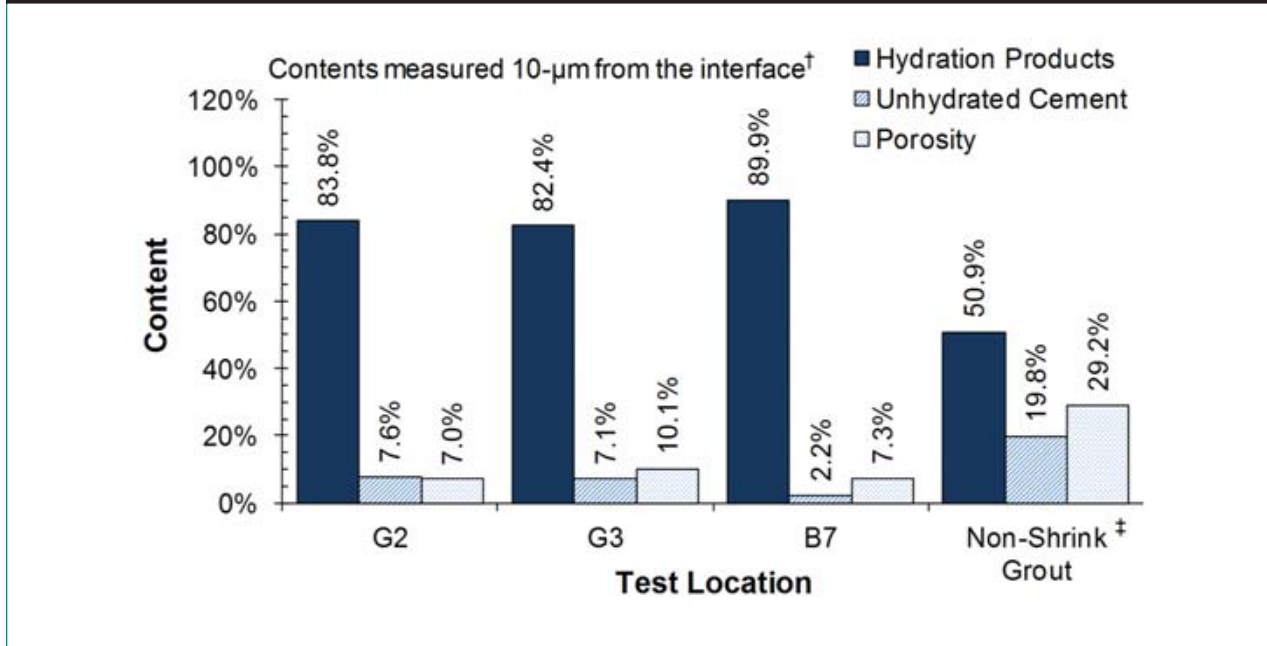
Figure 16. Representative results from microstructural analysis near the UHPC–concrete interface line.

†Aggregate content is not shown but was between 0 and 2.0 percent in each case.

‡Data from an on-going study at TFHRC– Grout A, control condition, bonded to an exposed aggregate surface.
