APPENDIX C: GAMPE FIELD TRIP GUIDE

Geotechnical Asset Management Peer Exchange (GAMPE)

FIELD TRIP GUIDEBOOK

August 28, 2019

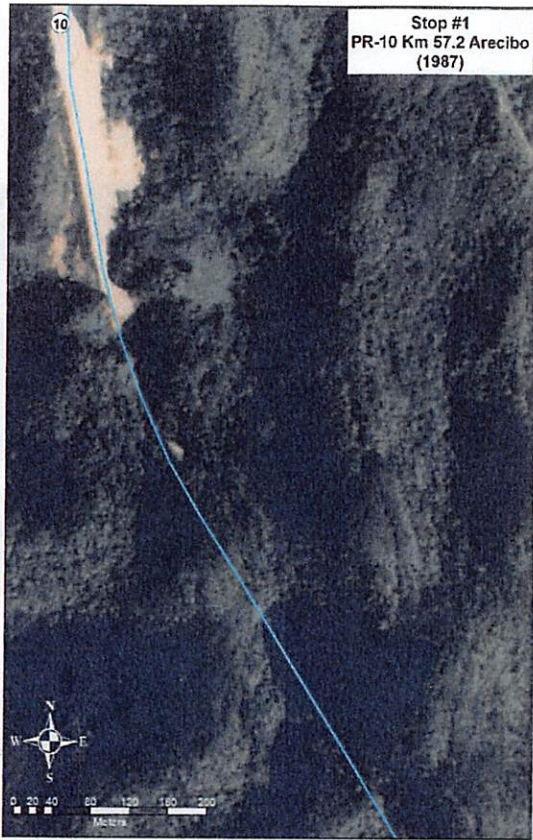
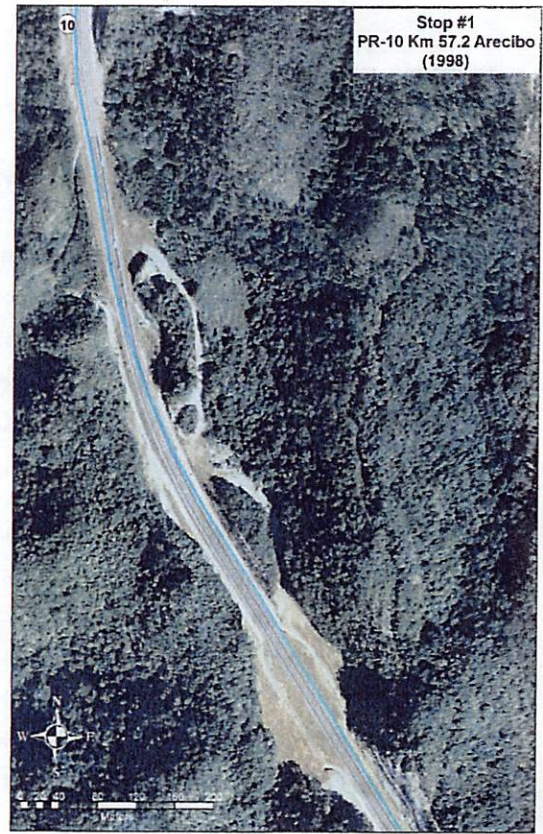
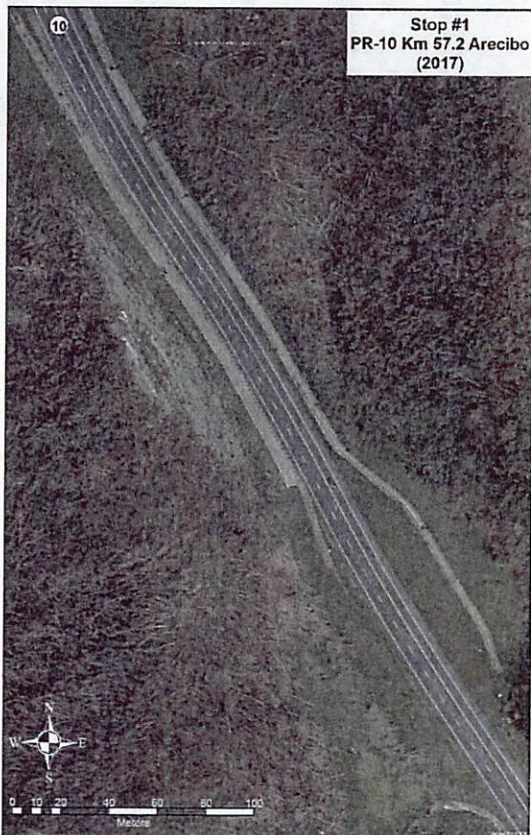
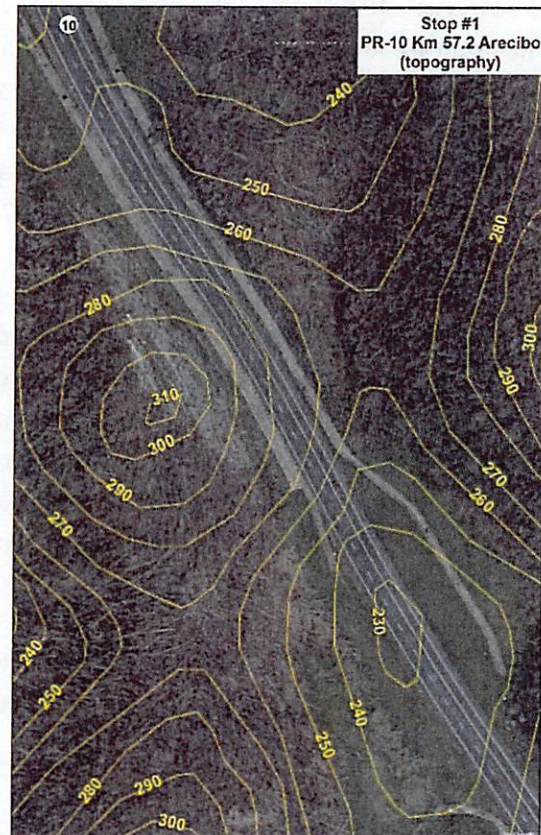
Stop #1 – PR-10 Km 57.2 Arecibo

This rock slope represents the section highway PR-10 that crosses the Río Abajo Forest. The nearly vertical rock cuts and small rockfall catchment areas between the roadway and the base of the slope resulted in part from the agreements established between DNER and PRHTA. To reduce impacts to the forest, the total width of this section of PR-10 had to be kept as small as possible.

The resulting rock cuts have not produced any significant rockfalls since their construction about 25 years ago. However, the rock of these “mogotes” (Montebello Limestone member of the Cibao Formation, Tcm) is not homogeneous, and the effects of differential erosion and raveling are starting to become an obvious problem. (See figure 12.)

Photograph **A** shows the view of the slope towards the south and photograph **B** towards the north. During our stop the vehicles will park on the relatively wide unpaved and grassy shoulder seen on photograph B. This wide area is a sinkhole that was “filled” during construction. (See 1987 and 1998 aerial images.)

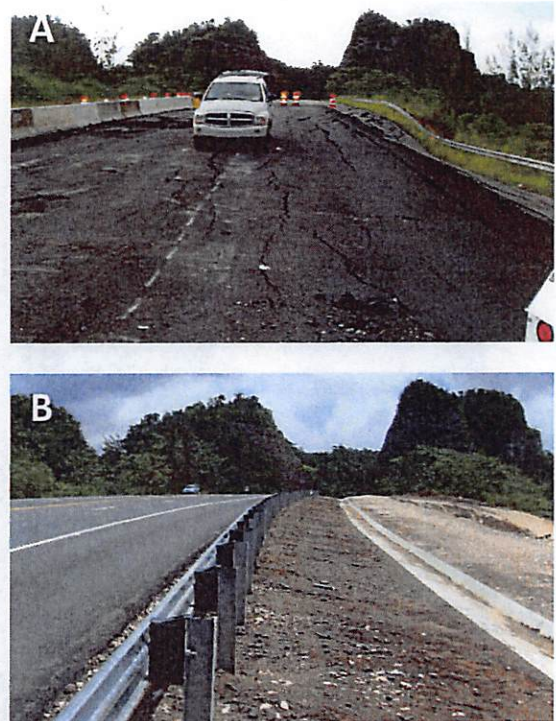
Figure 14. Condition of highway segment in 1998 and 2006, PR-10 Arecibo. (Stop #2)

This slope represents a fill or embankment section built over the contact between the Lares Limestone (Tl) and an underlying volcanoclastic sequence (Tj).

Figures 10 and 14 show that the fill started failing only a few years after construction ended. The conditions found during the landslide investigations determined that the best option available was to move this segment towards the west. Photograph A and B are from 2005 and 2008, respectively.

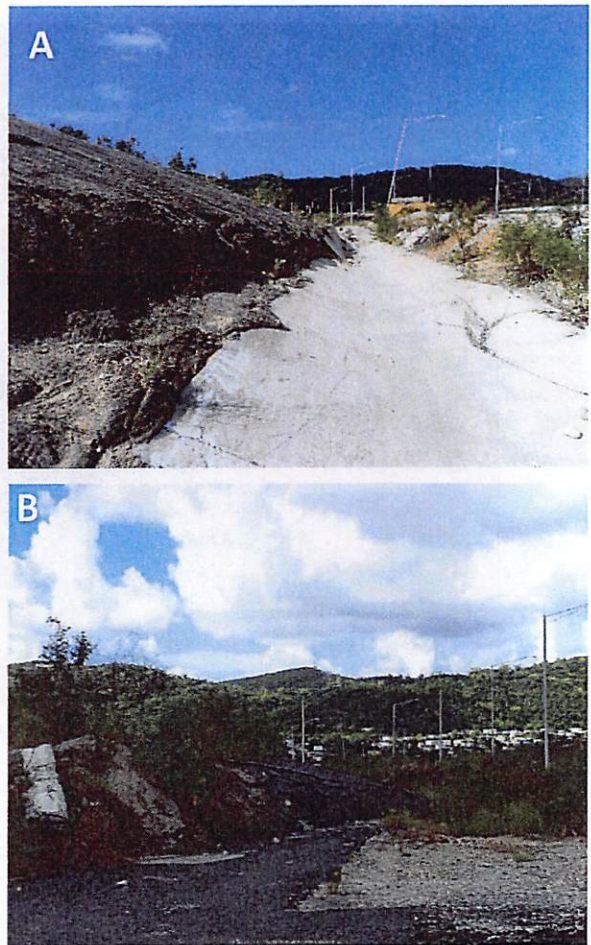
Figure 16. Slope failure PR-9 Ponce. (Stop #3)

This section of highway PR-9 involved the construction of two kilometers of new roadway and three bridges. Several slope failures have delayed its completion.

Photographs A and B are from 2016 and 2017 respectively. Figures 16-18 show an aerial view, the geologic map and a topographic map of the landslide, respectively.

The geology of this landslide consists of Juana Díaz Formation Chalk Member and underlying Mudstone Member. The Mudstone member contains highly plastic and expansive clays (montmorillonite).

Geotechnical recommendations include flattening the slope to 6H:1V and adding a drainage key.

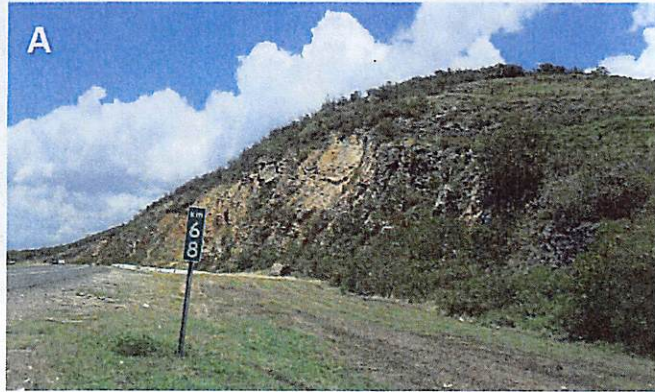
Stop #4 – PR-52 Km 68.3 Salinas

Aerial photographs show that this slope was cut as early as 1971. The material extracted from the site was used as fill in the construction of other sections of highway PR-52

Photographs A and B show a view of the slope towards the west and towards the east, respectively. Figure 19 shows that the slope was already inventoried and assigned a preliminary rating of A.
