Field Testing of an Ultra-High Performance Concrete Overlay

PUBLICATION NO. FHWA-HRT-17-096

AUGUST 2017

U.S. Department of Transportation
Federal Highway Administration

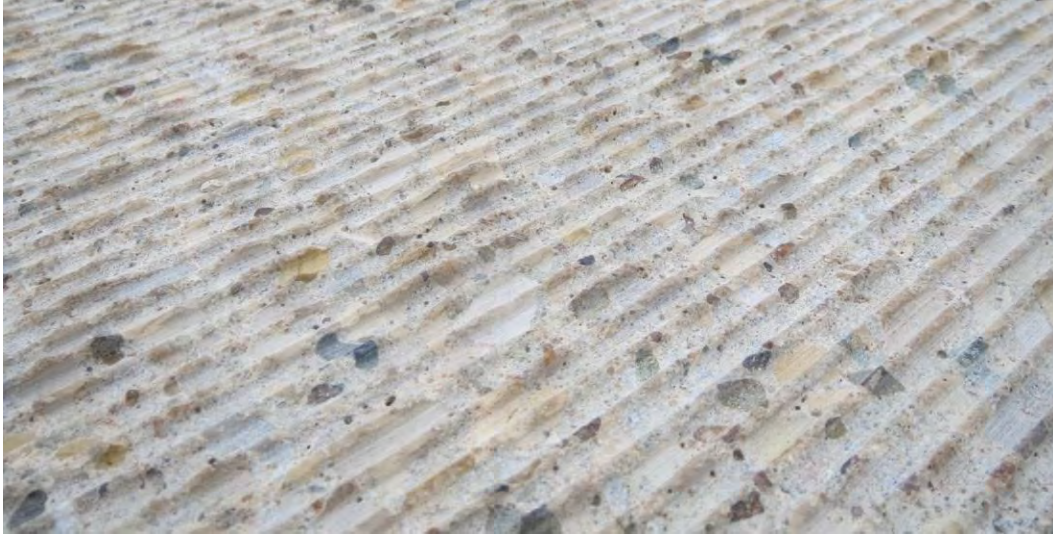
Figure 18. Photo. Deck surface after scarification.

As noted above, the existing surface of the deck was ground to remove poor concrete and provide a roughened surface to promote bond between the concrete substrate and the UHPC overlay material. A photo of the deck surface after scarification is shown in figure 18. On completion of the grinding, all fines and debris were to be removed from the surface of the deck, and deck surface was premoistened a few hours prior to installing the overlay.

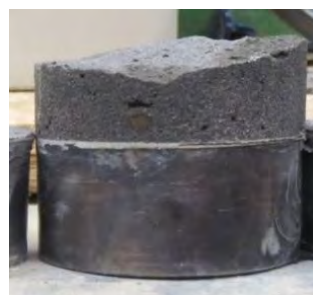
C. Mode 3: Failure in the bonded material.

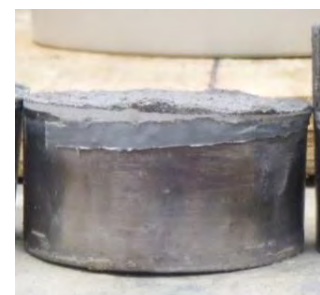
D. Mode 4: Failure in the disc adhesive.

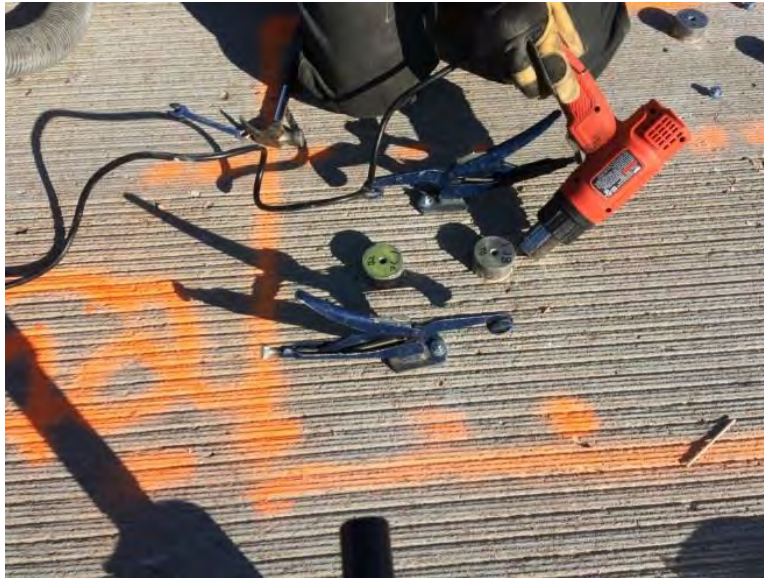
Figure 26. Photo. In-situ bond testing on the Laporte Road bridge.

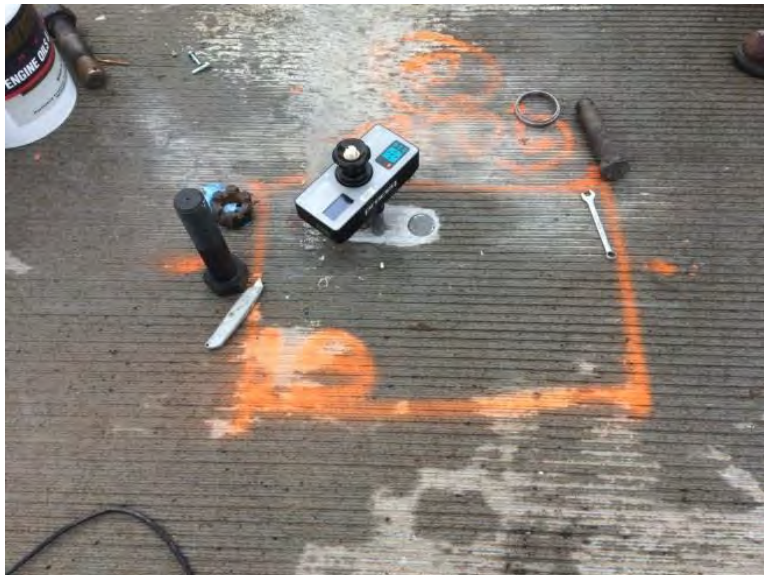
Figure 27. Photo. Preparation of the bond test location on the Laporte Road bridge.

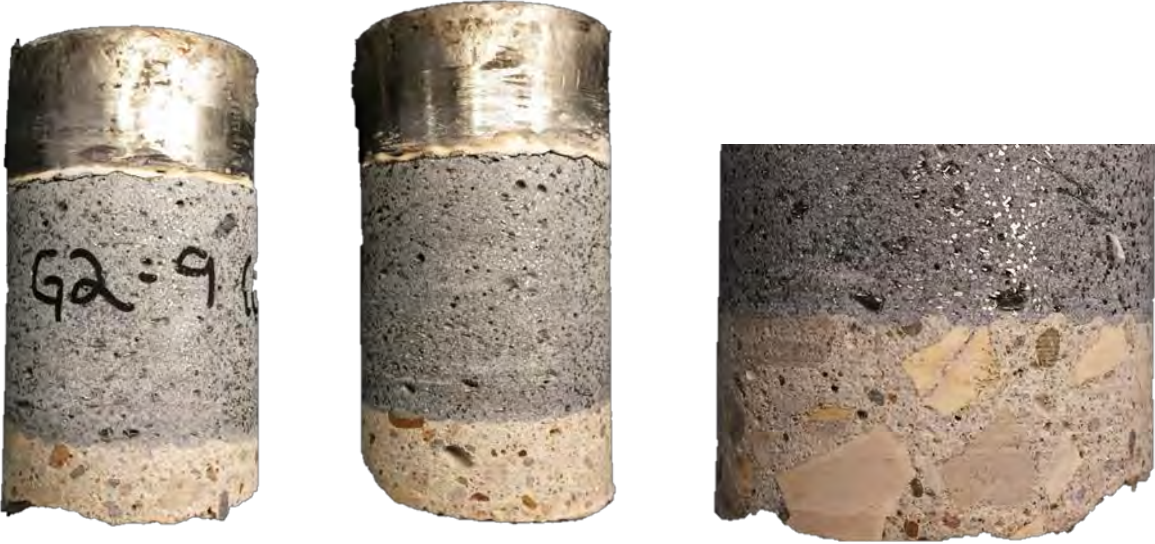
Specimens failing in Mode 4 were subsequently removed from the test location by applying a prying action to the sample using a hand tool. In each case, the prying action resulted in fracture of the substrate concrete. Figure 30 and Figure 31 show a representative sample (G2-9) from the G1 and G2 test locations. The bond between the UHPC overlay and the substrate concrete appears intact.

A. Front of G2-9 specimen after testing.

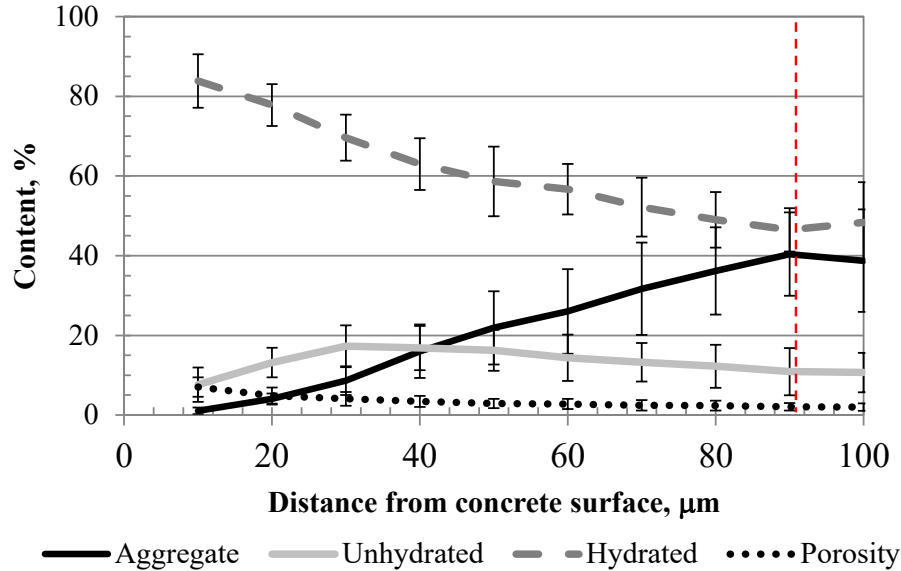
Distribution of the porosity, aggregate, unhydrated, and hydrated cement particles on the UHPC overlay as a function of the distance from the concrete surface is presented in figure 36. This graph shows a high content of hydrated products, above 80 percent, at the interface (from 0- to 10- μm distance). The percentage of hydrated products was reduced as the distance from the interface increased. This diminishing percent of hydrated products was caused by an increase of the aggregate content in the UHPC paste. At approximately 90- μm distance from the interface, the content of both hydrated and aggregate stabilized at from 46 and 40 percent, respectively. This effect has been observed in other types of overlays, and it is associated with reduction in the packing efficiency of the UHPC paste in the vicinity of the concrete surface, also known as “wall-effect.” (Garboczi and Bentz 1991; Ollivier, Maso, and Bourdette 1995; Scrivener, Crumbie, and Laugesen 2004; H Beushausen and Gillmer 2014) The inflexion point on the content of phases, hydrated product, and aggregates at 90- μm distance from the surface is depicted in figure 36 with a vertical dashed red line that marks the extent of wall effect on the UHPC paste.

Figure 36. Graph. Overall distribution at the interface as a function of distance from the concrete surface of specimen G2-8 phases.

The content of unhydrated cement was below 8 percent in the 10- μm gap close to the surface. The value reached a maximum of approximately 17 percent at 30 μm away of the surface and progressively decreased to 10 percent at 100- μm distance. The porosity also showed a maximum of 7 percent close to the interface in the 10- μm -wide gap close to the surface. The high packing efficiency of the UHPC and low water-to-cement ratios explained the comparative low values of porosity relative to other overlay configurations where ordinary portland cement or grout materials were used. These systems typically showed porosity values on the interface on the order of from 30 to 20 percent. (De La Varga et al. 2017; Hans Beushausen, Höhlig, and Talotti 2017)

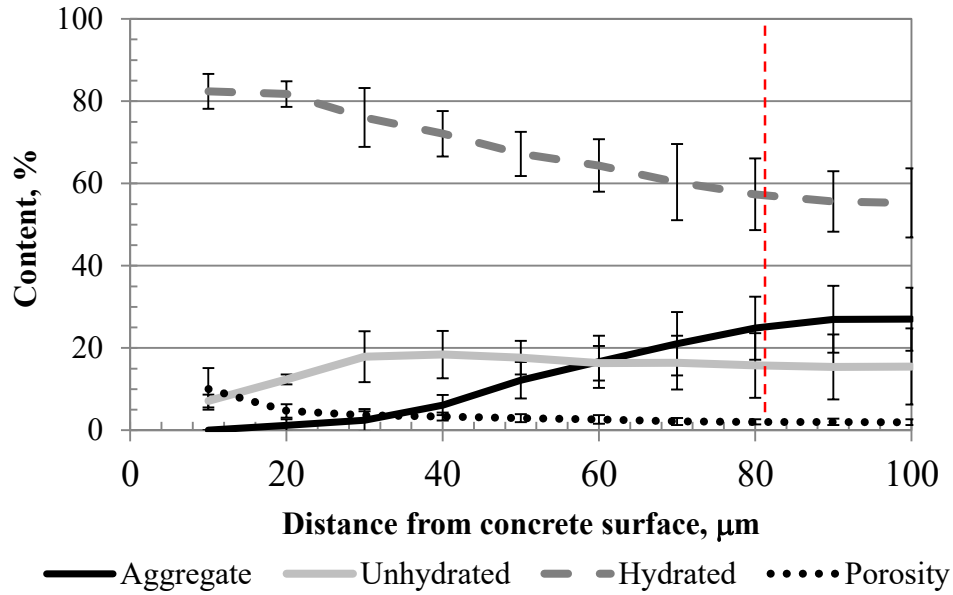
The trends in the distribution of phases on the interface for the G3-14 specimen, displayed in figure 40, were similar to those in the previous specimen, G2-8. Hydrated products of the UHPC paste were the principal phase in the first 100 μm of the interface microstructure. Its value progressively decreased from 80 percent in the first 0 to 10 μm to approximately 55 percent at 80 μm away from the concrete surface. In parallel to the decrease in hydrated products, the aggregate content increased from 0 percent right at the interface to a value of approximately 25 percent at 80 μm . The content of both unhydrated particles and porosity evolved following the same trend as the one observed in specimen G2-8. In the case of the unhydrated particles, the initial 8 percent content right at the surface increased to approximately 20 percent at 30 μm away of the surface and progressively decreased to 10 percent at 100- μm distance. While at initial 10 percent value of porosity, the interface constantly diminished to below 2 percent at 100- μm distance from the surface.

Finally, the distribution graph in figure 40 also confirms a reduction in the extent of the UHPC paste affected by the wall effect induced by the “plateau” configuration of the concrete surface. The inflexion point in this G3-14 specimen was observed at 80- μm distance from the surface instead of the 90- μm mark registered in the previous specimen (G2-8).

Figure 40. Graph. Overall distribution at the interface as a function of distance from the concrete surface of specimen G3-14 phases.

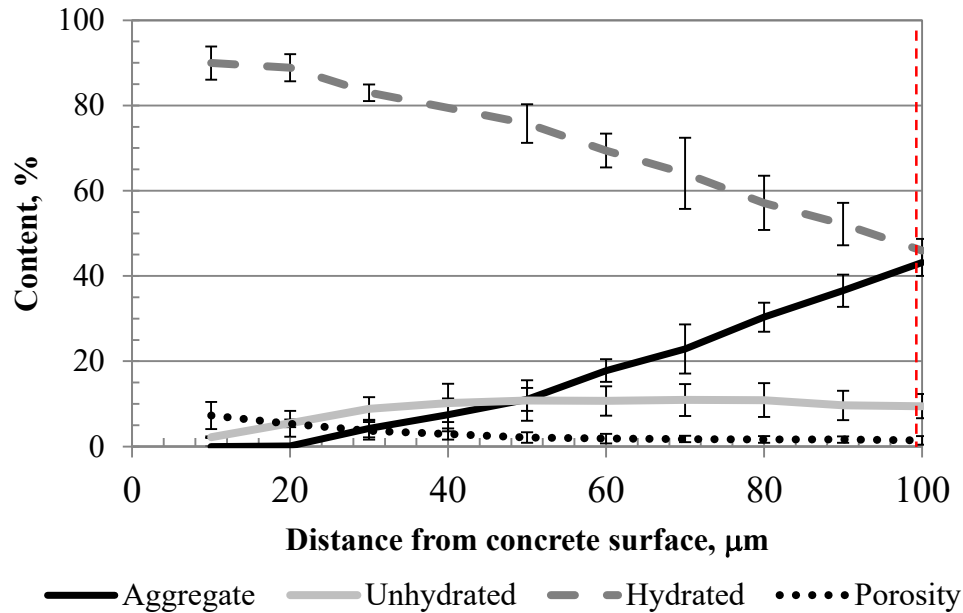
As shown in figure 44, the results of quantitative analysis for this specimen are similar to those measured in G2-8. At the interface, the hydrated products were above 80 percent, and porosity was around 7 percent. The aggregate content showed a similar evolution, reaching 40 percent at 100- μ m distance from the interface. This similarity with the G2-8 specimens also extended to the distance where the inflexion point in the trend of hydrated particles and aggregate was located. Based on the data shown in figure 44, it was inferred that this limit was located close to 100- μ m distance from the surface. Significantly, this sample came from a location where the concrete surface was subjected to scarification. Thus, as in specimen G2-8, the distance from where the inflexion point occurred was significantly higher than the distance observed for the nonscarified sample (G3-12).

Figure 44. Graph. Overall distribution at the interface as a function of distance from the concrete surface of the specimen B7-12 phases.
